**PROJECT NAME** MQANDULI SECONDARY BULK WATER SCHEME - CONTRACT 2  
**PROJECT SCOPE** Construction of 4 Reservoirs, and a Secondary Bulk Main  
**CO ORDINATES** Latitude: 29°15' 55.21"South, Longitude: 30°48' 45.77"East  
**CONTRACT No** ORTDM SCMU 49-18/19

Delays as a result of the Worldwide Covid 19 Pandemic has hampered the project progress, but the Contractor has developed a catch up plan in order to expedite the progress. The 1.5 km 110mm Pipeline has been completed and all Reservoirs are currently under construction, as pictured below.

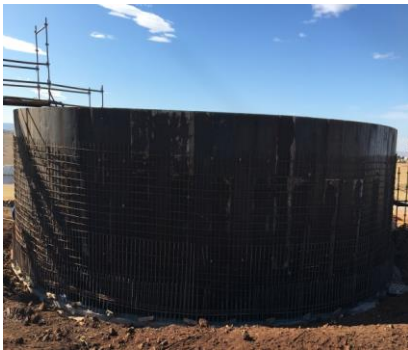
**1ML Reservoir Mandlovini- Steel fixing and wall shuttering**

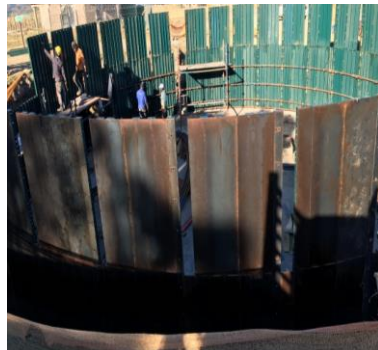
**500 KL Reservoir Maqomeni- Steel fixing and wall shuttering.**

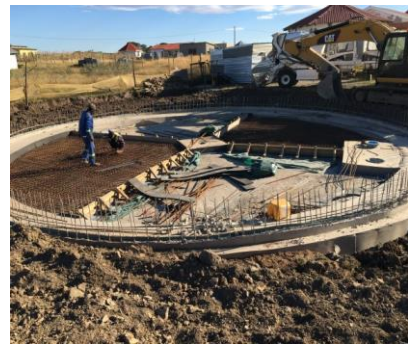
**500 KL Reservoir Zwelitsha- Floor Quadrants steel fixing.**

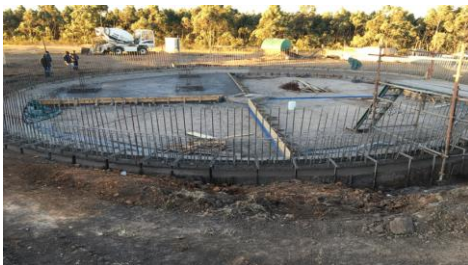
**1ML Reservoir Cezu - Floor Quadrants steel fixing**

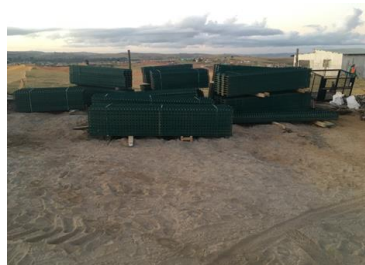
**Material on site- Reservoir Wall Shutters**
