ENGINEERING SERVICES CHIEF DIRECTORATE

PROJECT DETAILS	
CLIENT DEPARTMENT	South African National Defence Force
PROJECT NUMBER:	N/A
REPORT TITLE	Flood damage investigation into collapsing perimeter boundary wall

REPORT STAGE			
	Investigation Report	Status Quo Report	Preliminary Design Report
	IR	SQR	PDR
Tick [x]	x

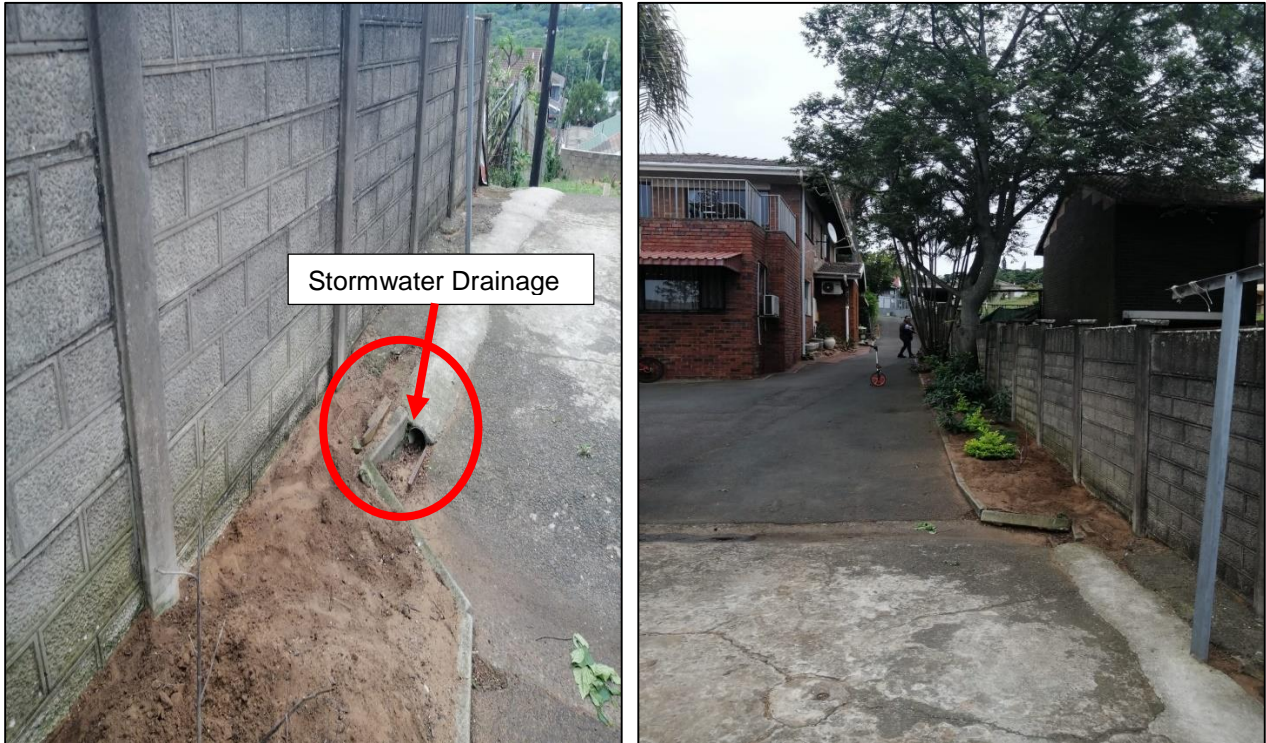
- The property at 49 Ettrick Road had approximately 30 meter stretch of asphalt surfacing sloped along the boundary wall. The drainage provided was a 150mm diameter PVC pipe trenched into the driveway along the properties at 2 Periwinkle Garden and 2 Gansbaai Place. The outlet is within the property onto the open area natural ground running along the wire mesh fence of 2 Gansbaai Place. Refer to Figure 3-2 and Figure 3-3.

Figure 3-2: Private Dwelling - Site drainage, Surfacing and Precast Concrete Slab Fence

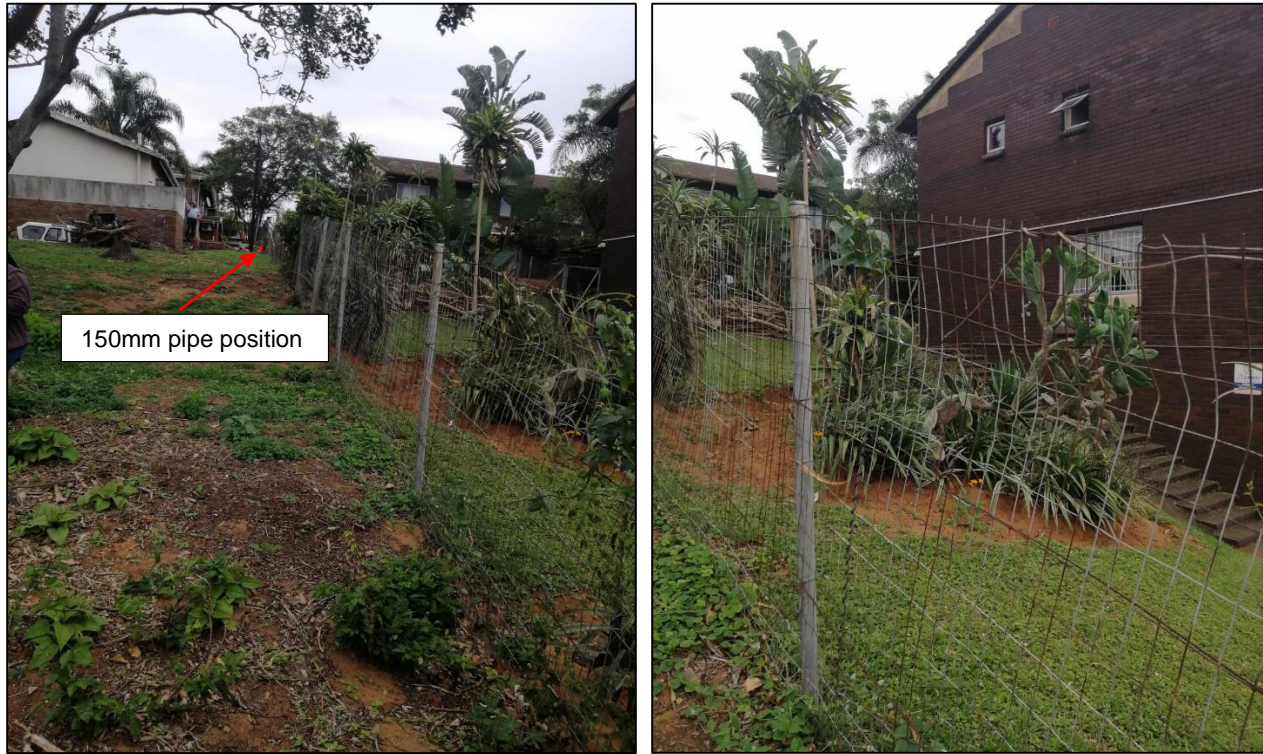
Figure 3-3: Position of Private Property Drainage Pipe onto Open Ground within Property and Visual of Adjacent SANF Dwelling with Wire Mesh Fencing

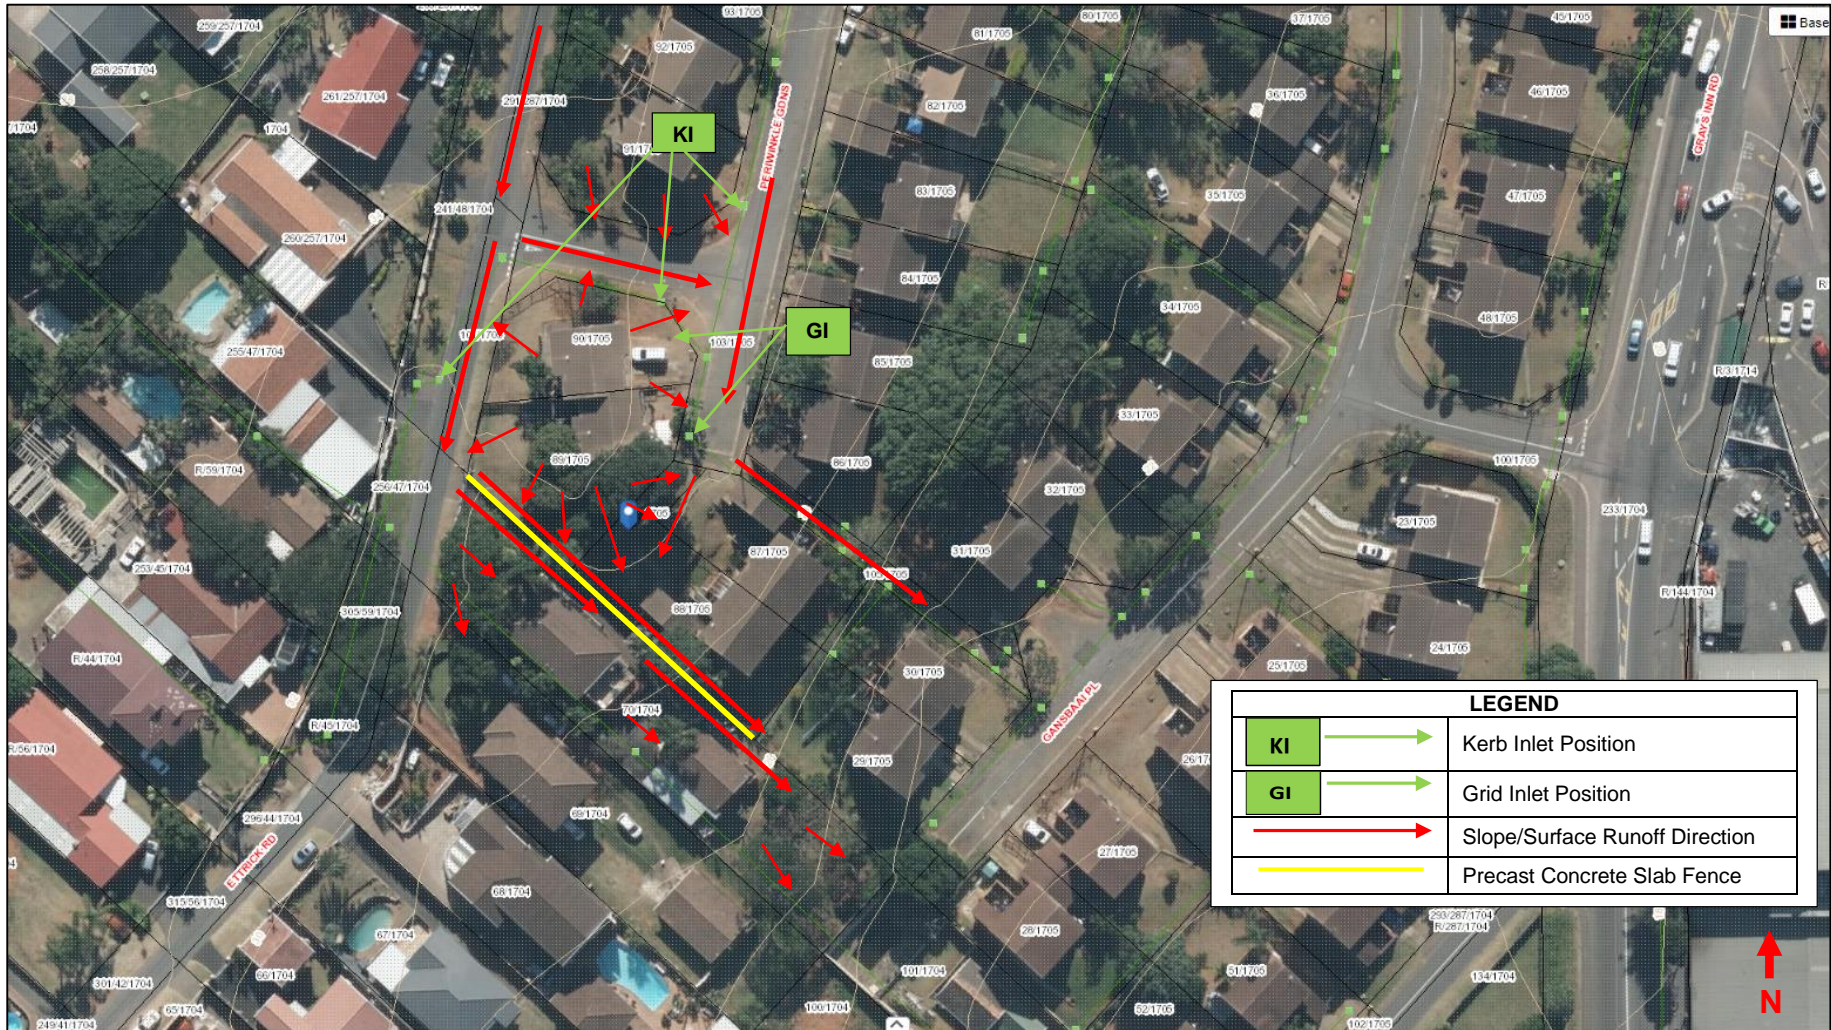
Figure 4-1 is an illustration of the direction of surface flow runoff that potentially contributes to the affected boundary fence that runs along the three properties that include 1 Periwinkle Garden as a contributor. The municipal stormwater (SW) infrastructure in the affected area was comprised of the 3 marked kerb inlets (KI), 2 grid inlets (GI) and 2 SW manholes (MH) as indicated in Figure 4-1 and Figure 4-2.

The stormwater sheet flow is illustrated in Figure 4-1 and Figure 4-2 flows eastward towards the affected property along and municipal stormwater drainage network is shown to run along the road network in the perimeter. The runoff that had affected the boundary wall had no formal drainage network alleviating stormwater runoff volume within the two properties, 1 and 3 Periwinkle, that collects against the 49 Ettrick. The state of the existing municipal stormwater network could not be determined and the level of maintenance could not be established.

Figure 4-1: Runoff Direction, Affected Boundary Fence and Municipal Stormwater Infrastructure

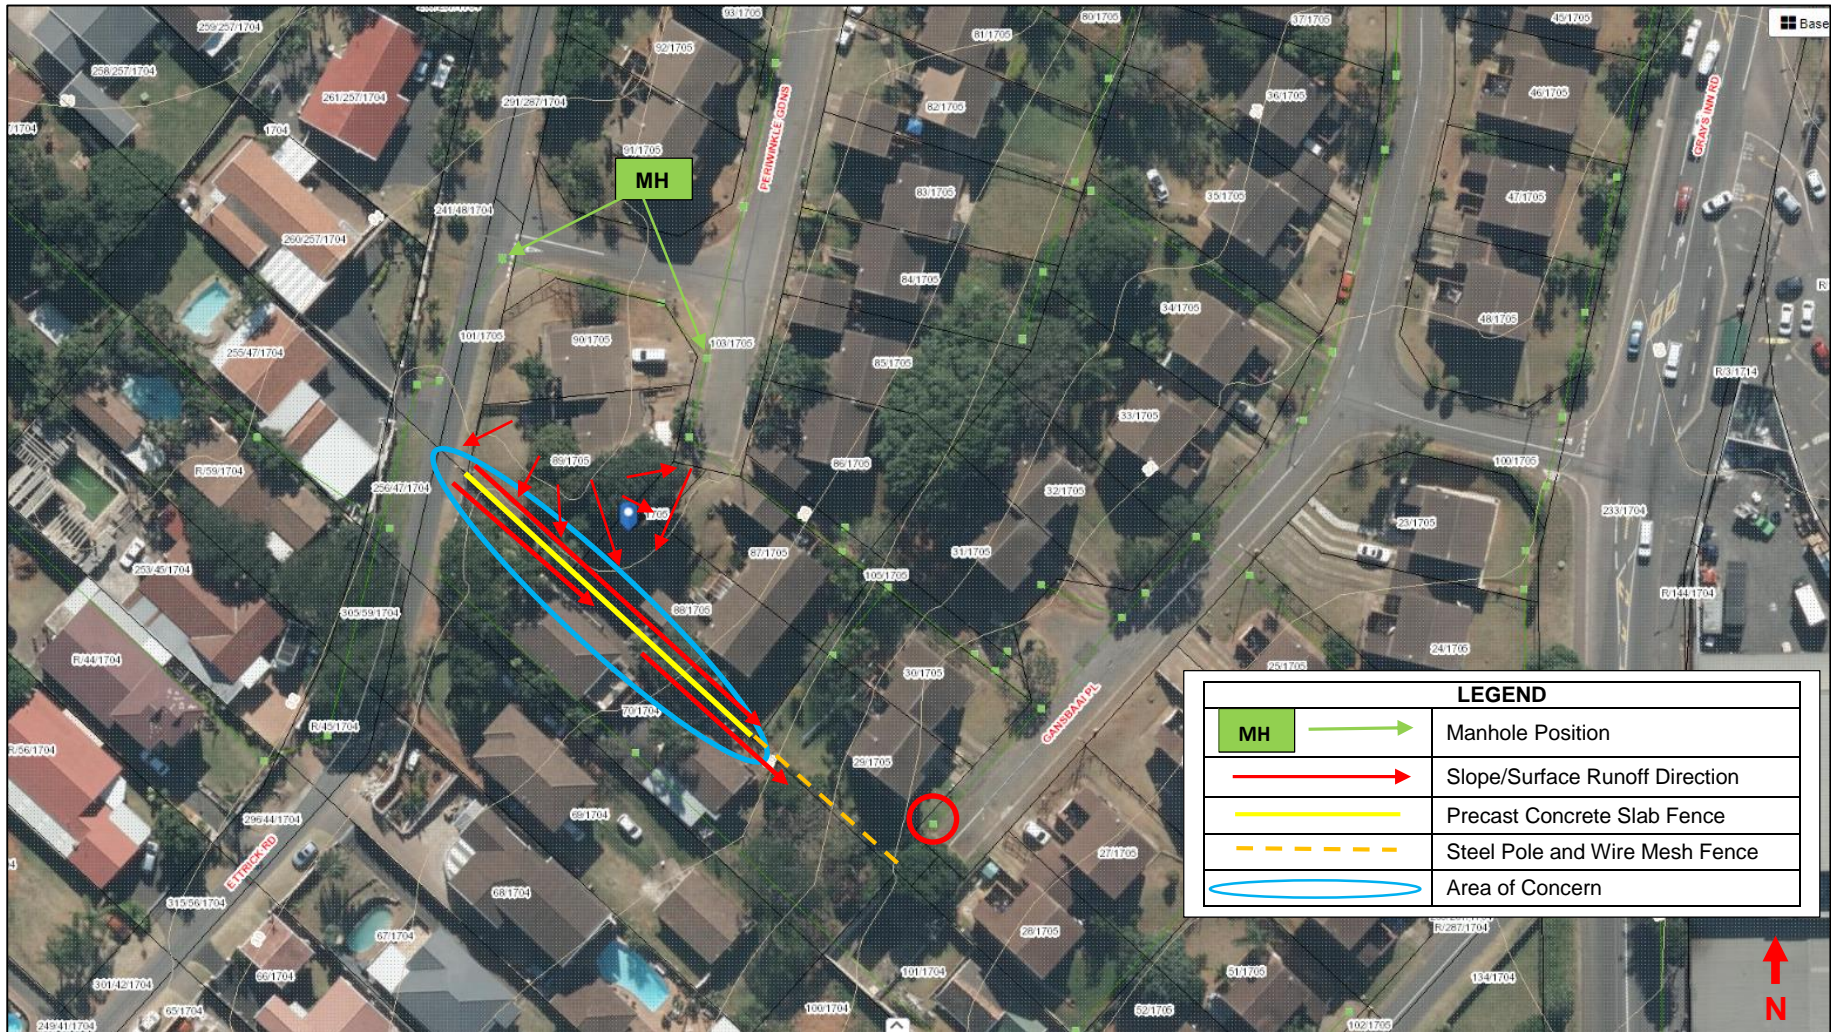
Figure 4-2: Affected Property Boundary Fence and Closest Stormwater Receiving Infrastructure

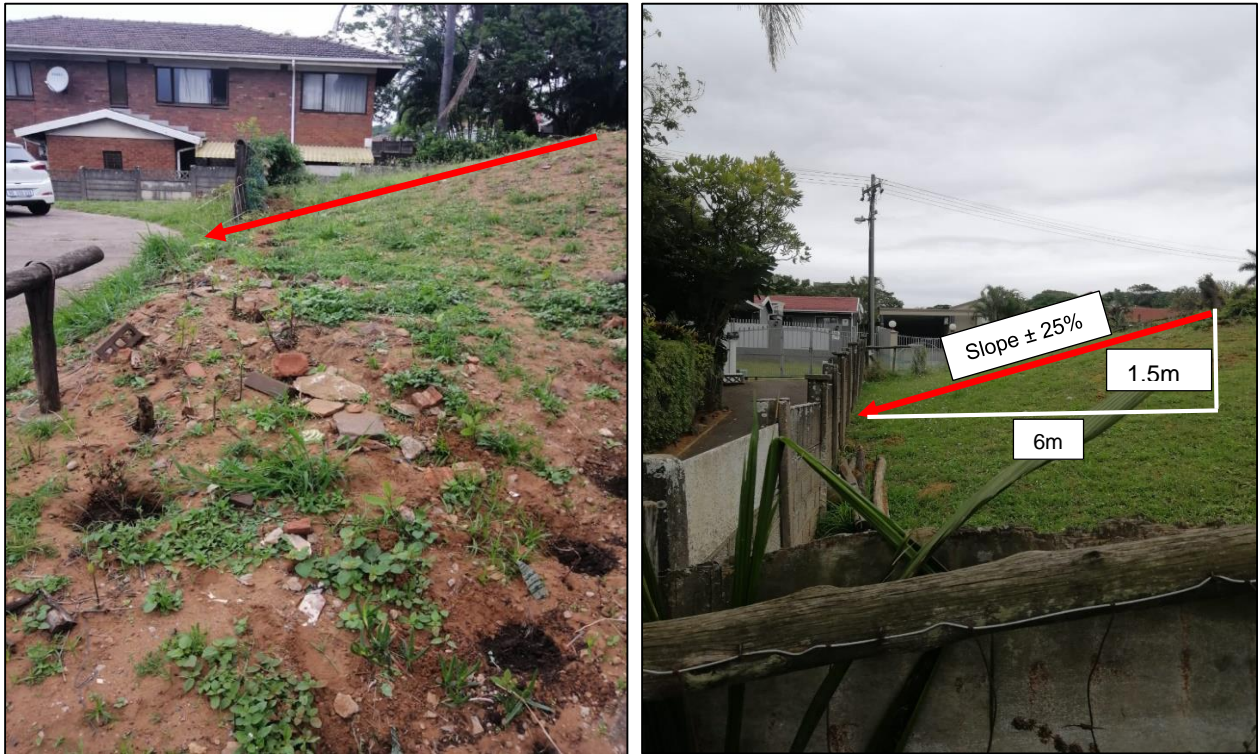
The approximated height, distance and slope were measured and calculated at 1.5m, 6m and 25% respectively as illustrated in Figure 4-3. The average distance measured along the flattest plain from the base of the slope to the boundary along the three properties was 1.5m referenced in Figure 4-4. Accumulated runoff from Ettrick Road and Periwinkle Garden has a potential of reaching the boundary fence in times of heavy rains. Figure 4-5 illustrates the created channel against the private property boundary fence and the slope from 1 and 2 Periwinkle properties channelling runoff into the back yard at 2 Periwinkle.

Figure 4-3: Slope Running Parallel to Affected Private Property Precast Concrete Slab Fencing

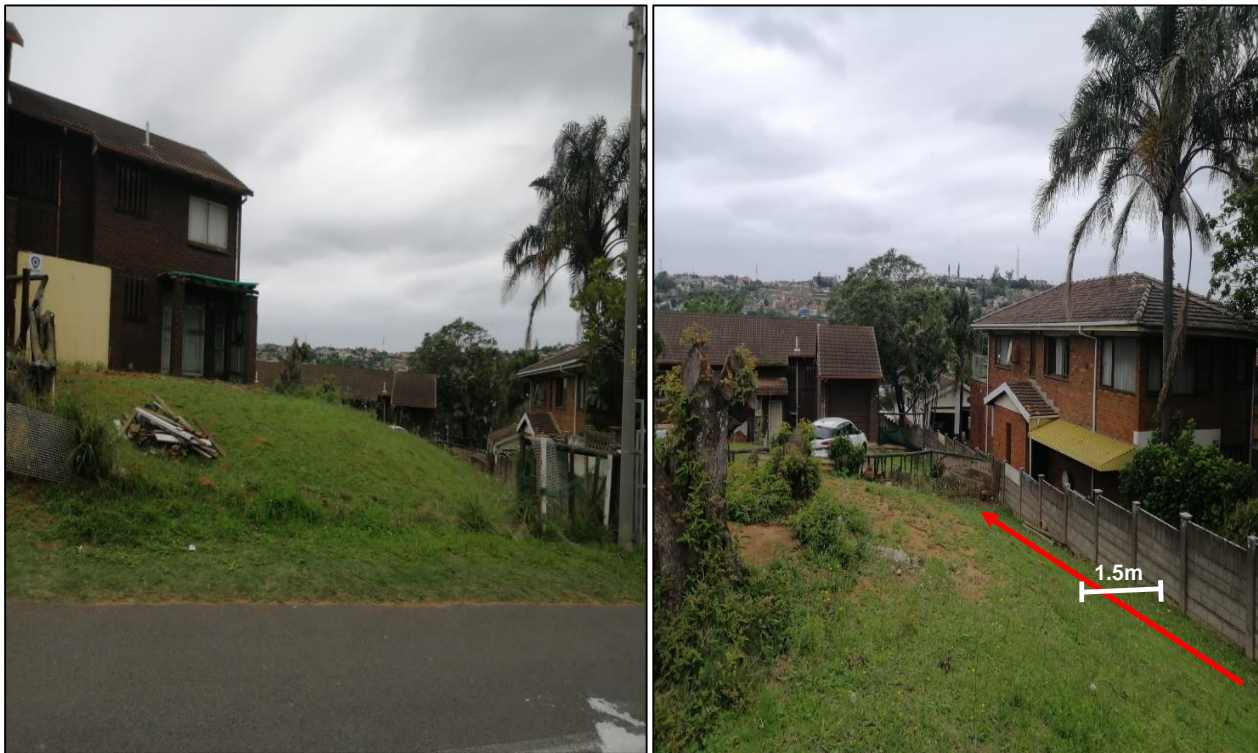
No stormwater drainage was identified within the properties lined along the private dwelling on 49 Ettrick Road, namely at numbers 1 and 2 Periwinkle Garden. The surface runoff contributing area slopes perpendicular and parallel to the private dwelling's affected precast concrete slab fencing as referenced in Figure 4-3 and Figure 4-4. The slope at 1 Periwinkle created an open channel against the concrete slab fence at 49 Etterick Road. The concrete slab wall retained an approximated soil volume with an average height of 300mm on the up slope on 1 Periwinkle Garden no weep holes into 49 Ettrick over a length of 30m. The ground conditions at 1 and 3 Periwinkle were identified as sandy with grass cover. The SANDF property on 2 Periwinkle Garden could not be accessed but the ground conditions at 2 Periwinkle were observed to show signs of erosion with stripped grass cover and exposed sand (potentially from the dogs running up against the fence).

Figure 4-4: Slope Running Perpendicular to Affected Private Property Precast Concrete Slab Fencing

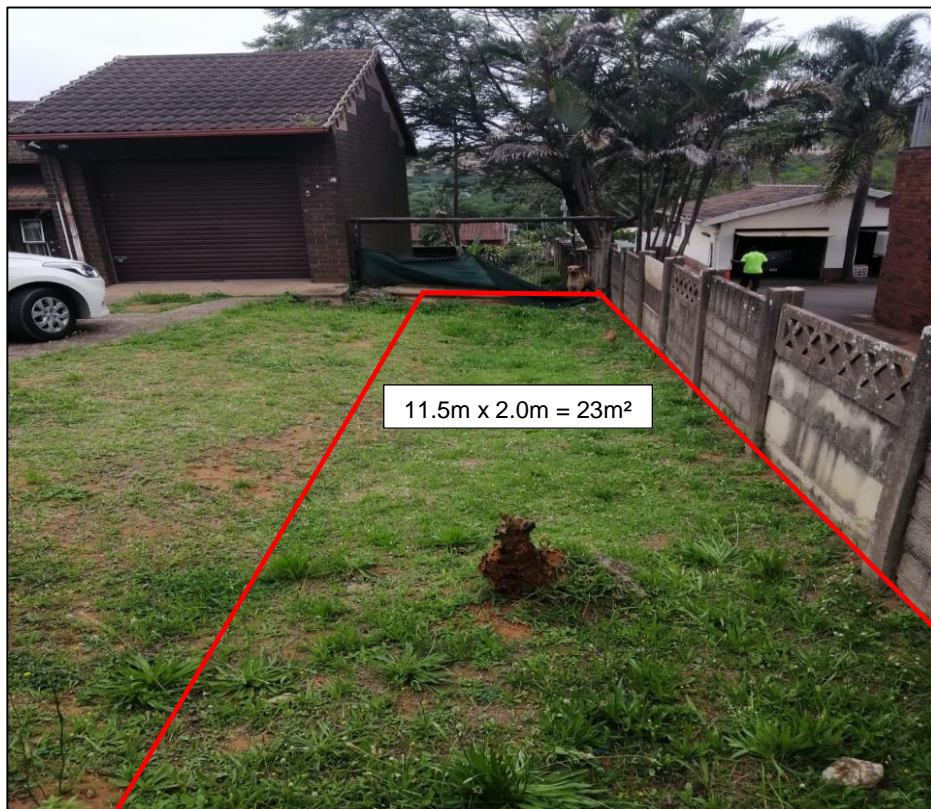
Figure 4-5: Channelling Point against Private Boundary Fence from 1 and 2 Periwinkle into Back Yard at 2 Periwinkle

The natural ground is a better drainage consideration that can be enhanced by the introduction of plants as a landscaping intervention to naturally reduce sheet flow and promote infiltration. A perforated 250mm pipe introduced beneath the collection area at the bottom of the slope along the 49 Etrick Road's boundary wall will assist the soil's ability to absorb water faster to be discharged into the municipal stormwater network on Gansbaai Place.

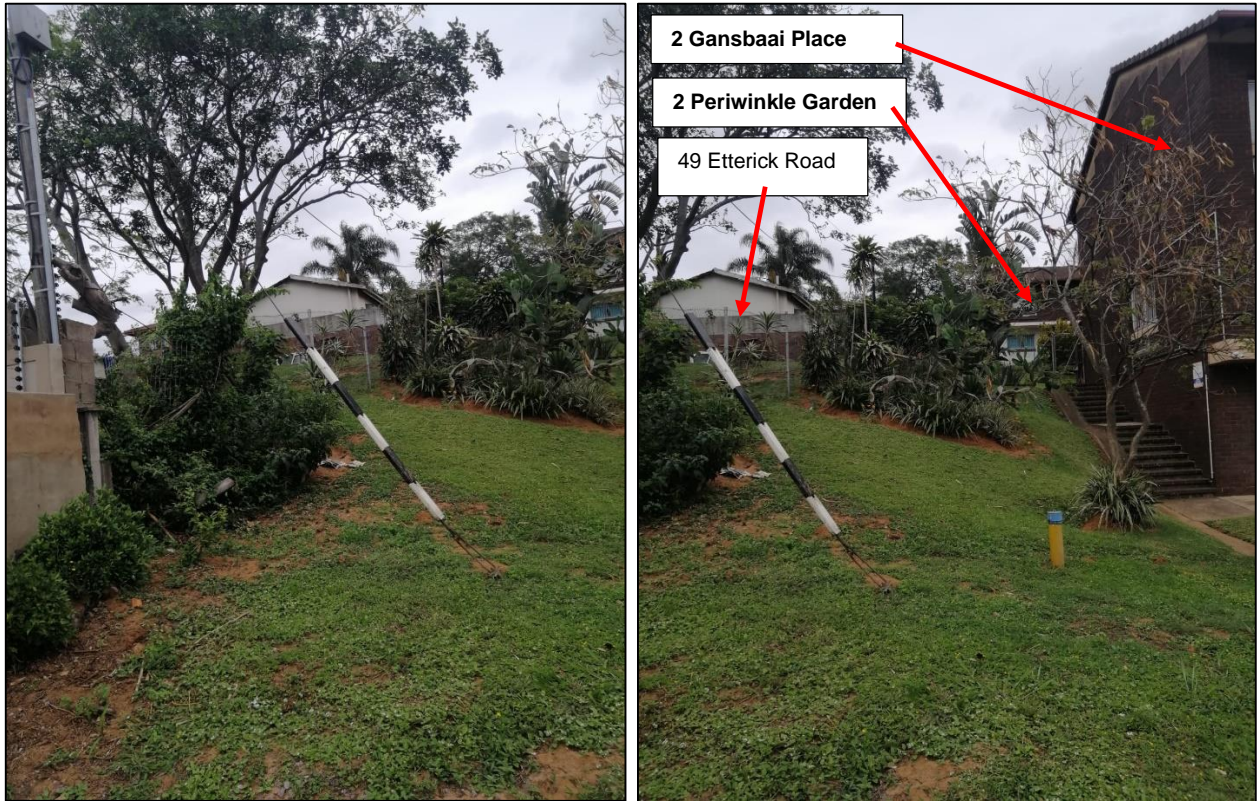
Figure 4-6: Vegetation cover on 2 Gansbaai Place on bottom end to 49 Etterick Road and directly below 2 Periwinkle Garden

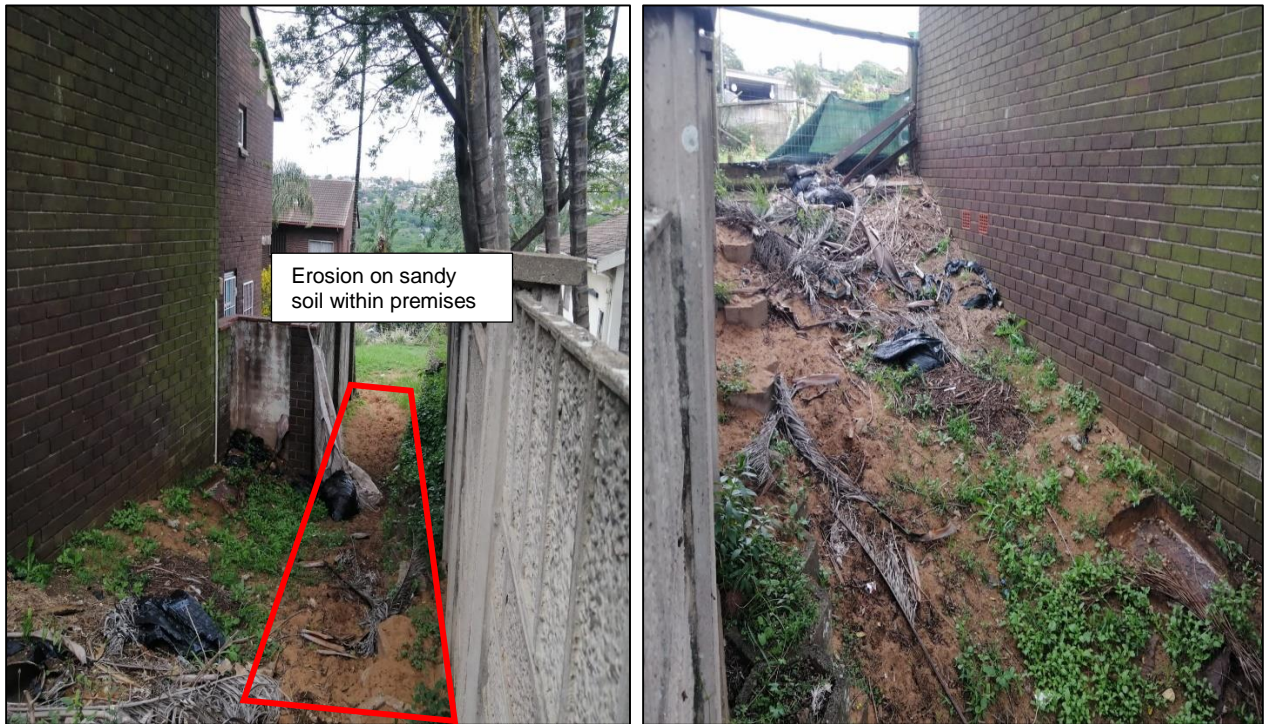
Along 2 Periwinkle's boundary were loffelstein reinstalled at stepped stacked heights of between 2 and 3 units along the precast concrete slab wall at a length of 15m.

Figure 4-7: Corrosion path downhill along retainers

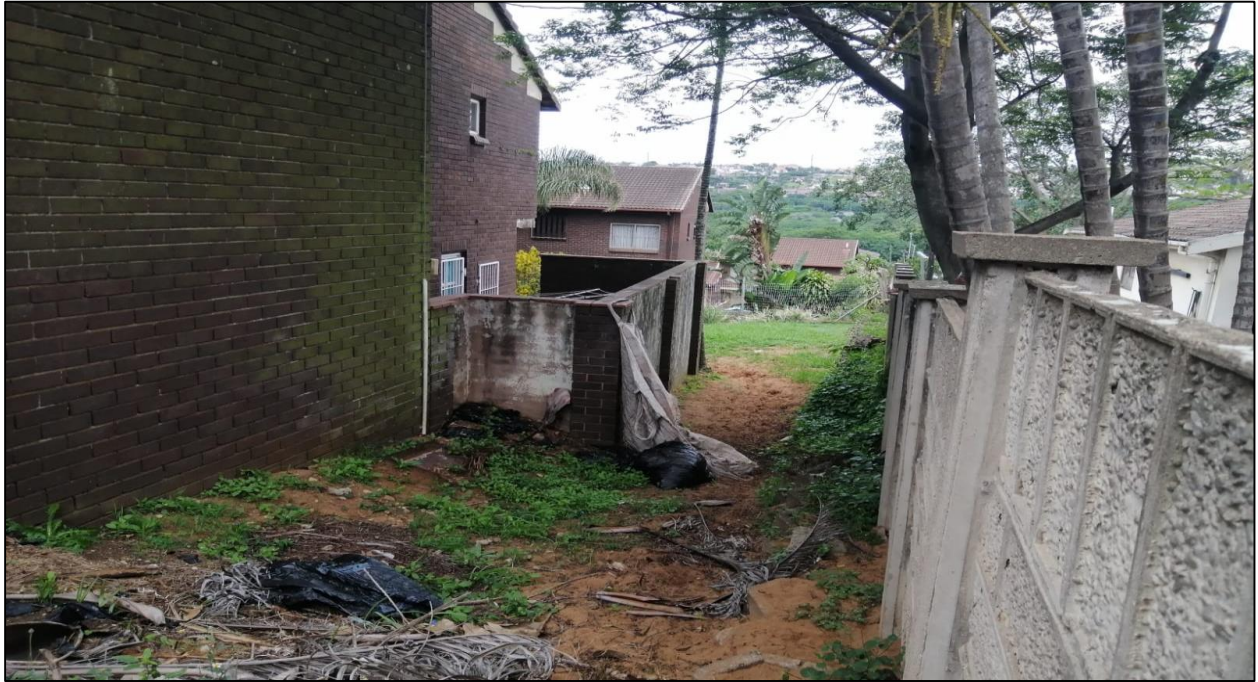
Figure 4-8: Signs of downhill erosion at 2 Periwinkle Garden along 49 Etterick Road's Boundary fence
