Chemwes Proprietary Limited

19 September 2018

RE: INTERIM PROGRESS REPORT – PROCESS WATER OVERFLOW AT KAREERAND TAILINGS STORAGE FACILITY RETURN WATER DAM ON 21 FEBRUARY 2017.

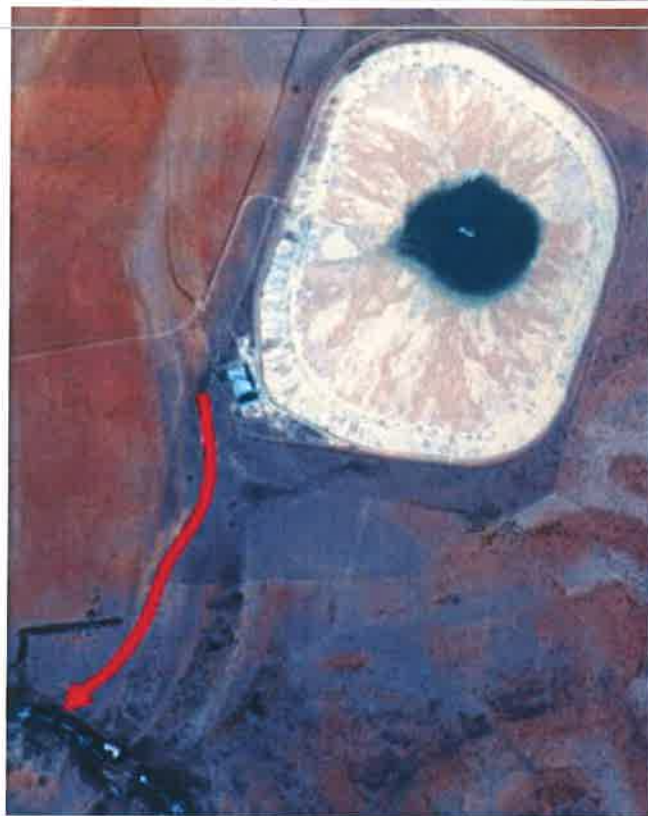
On the 21st of February 2017, following a heavy rainstorm event of more than 50mm in less than 3 hours, the return water dam at Kareerand overflowed into the drainage line and subsequently discharged downstream into the Vaal River.

Figure 1: Drainage line towards the Vaal River

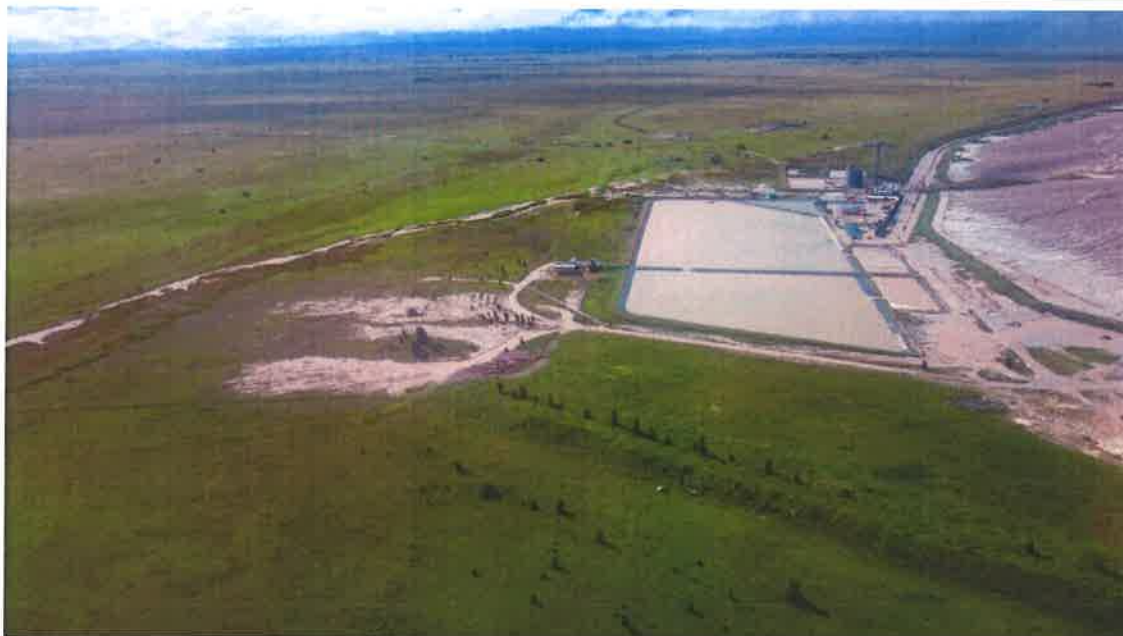
In addition to the return water overflow, storm water and some tailings material from the area surrounding the Kareerand tailings dam also spilled towards and into the Vaal River.

Figure 2: Spillage towards the Vaal River (21 Feb 2017)

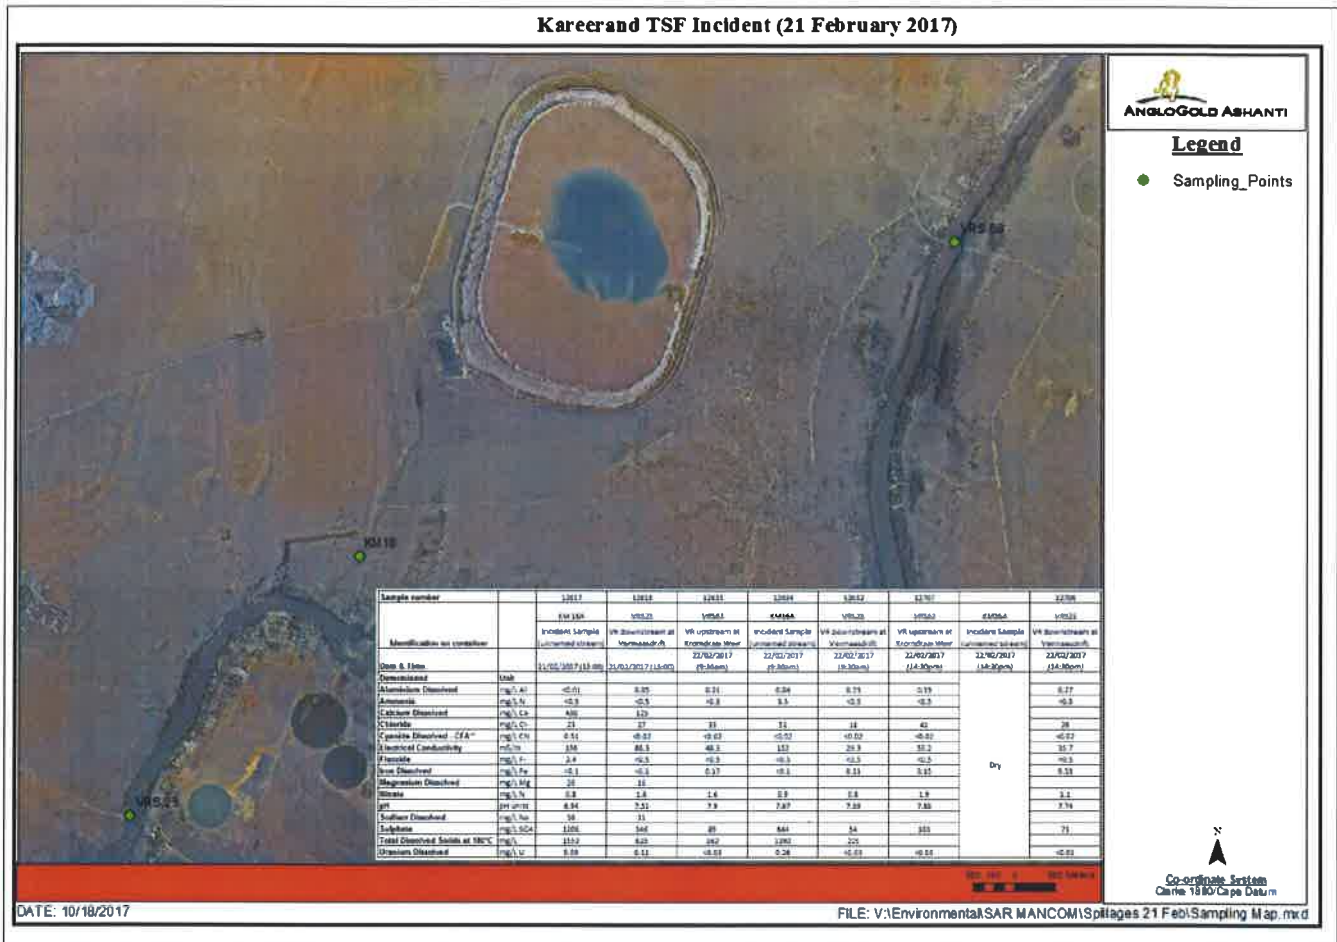
Water quality samples were taken at KM16, downstream of the Kareerand TSF in the unnamed tributary, and VRS23, inside the Vaal River downstream of Kareerand discharge at Vermaasdrift, on the day of the incident. The water quality results of the samples and locations is shown in Figure 3. Water quality samples on the 22nd of February 2017 were taken at KM16, VRS 23 and VRS63 inside the Vaal River upstream of Kareerand TSF at the Kromdraai Weir.

Figure 3: Kareerand Incident Sampling locations and Water Quality Results

Vaal River sample analysis indicated that Total Dissolved Solids (TDS) and Sulfate exceeded the regulatory instream water quality objectives, 585mg/l (vs 560mg/l limit) and 346mg/l (vs 160 mg/l limit) respectively during the incident.

The cyanide levels in the discharge and the Vaal River remained within limits.

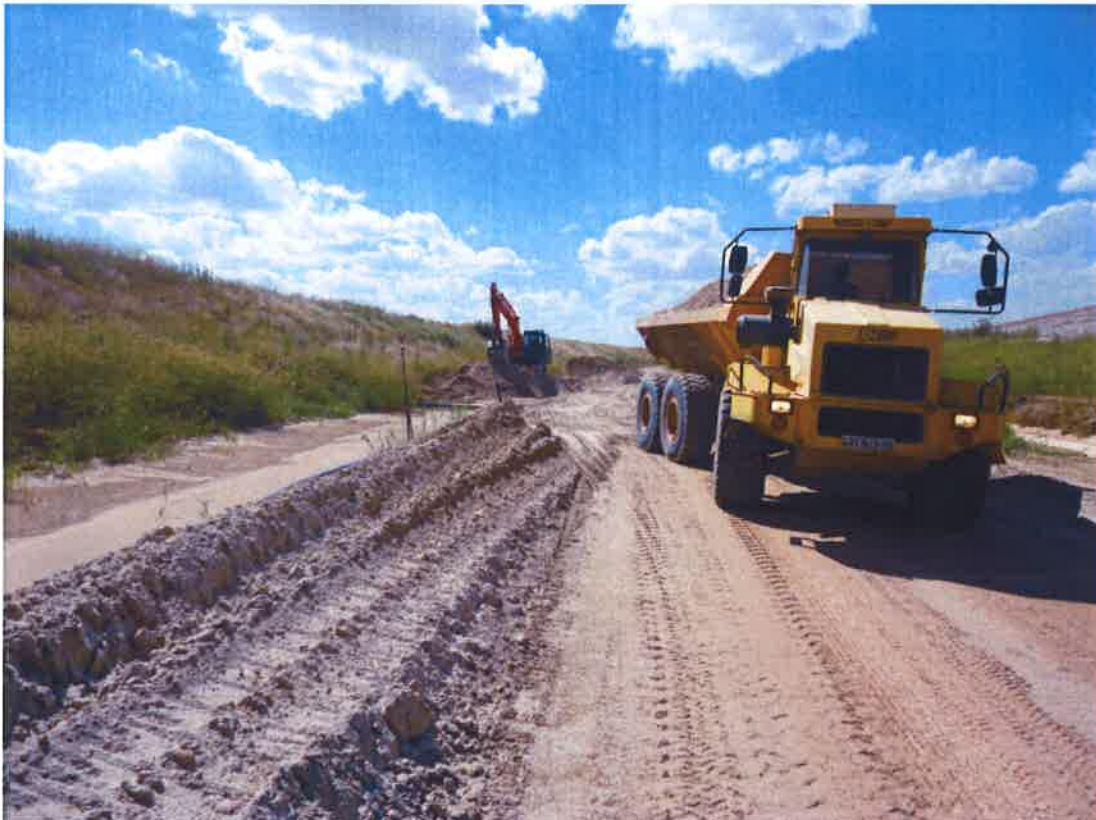
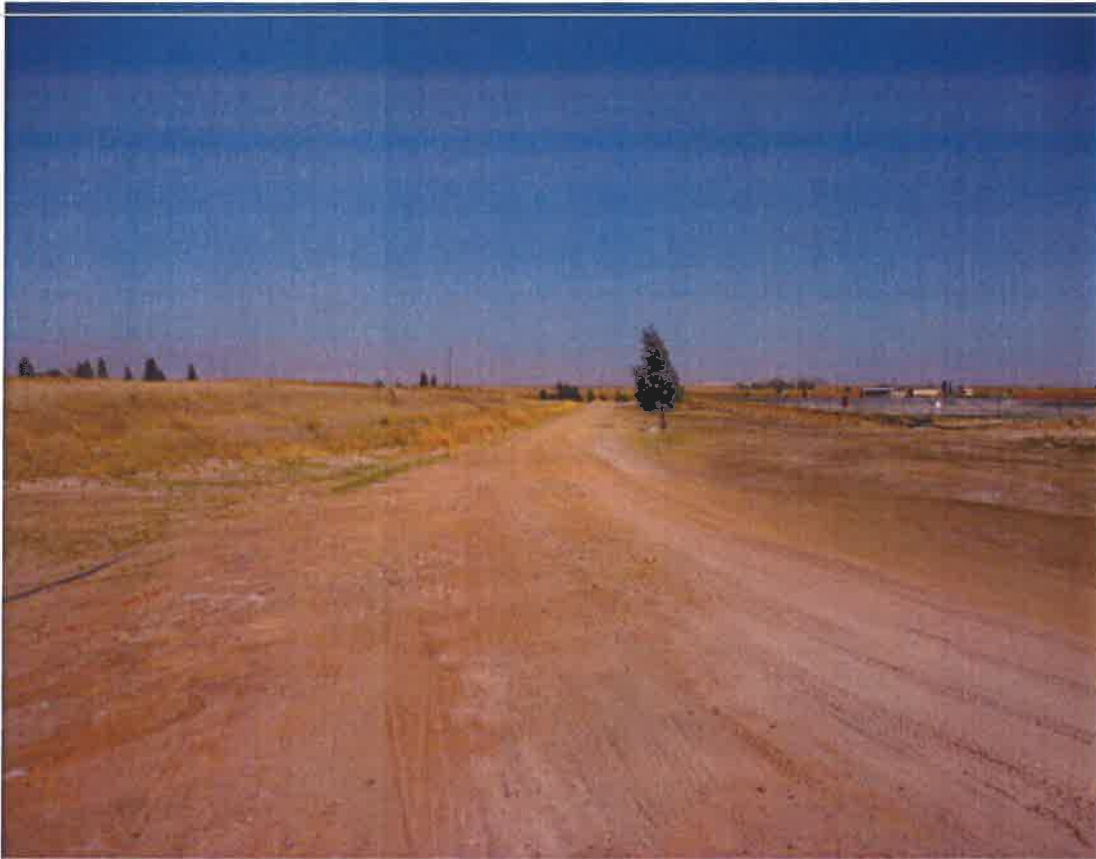
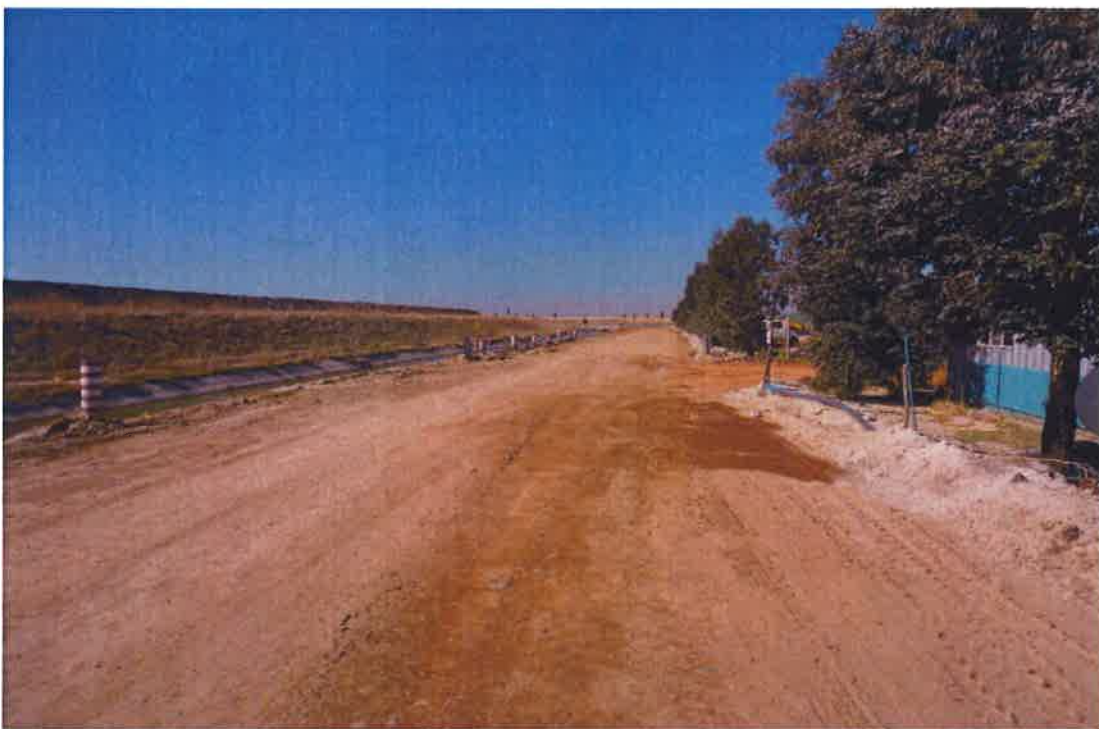
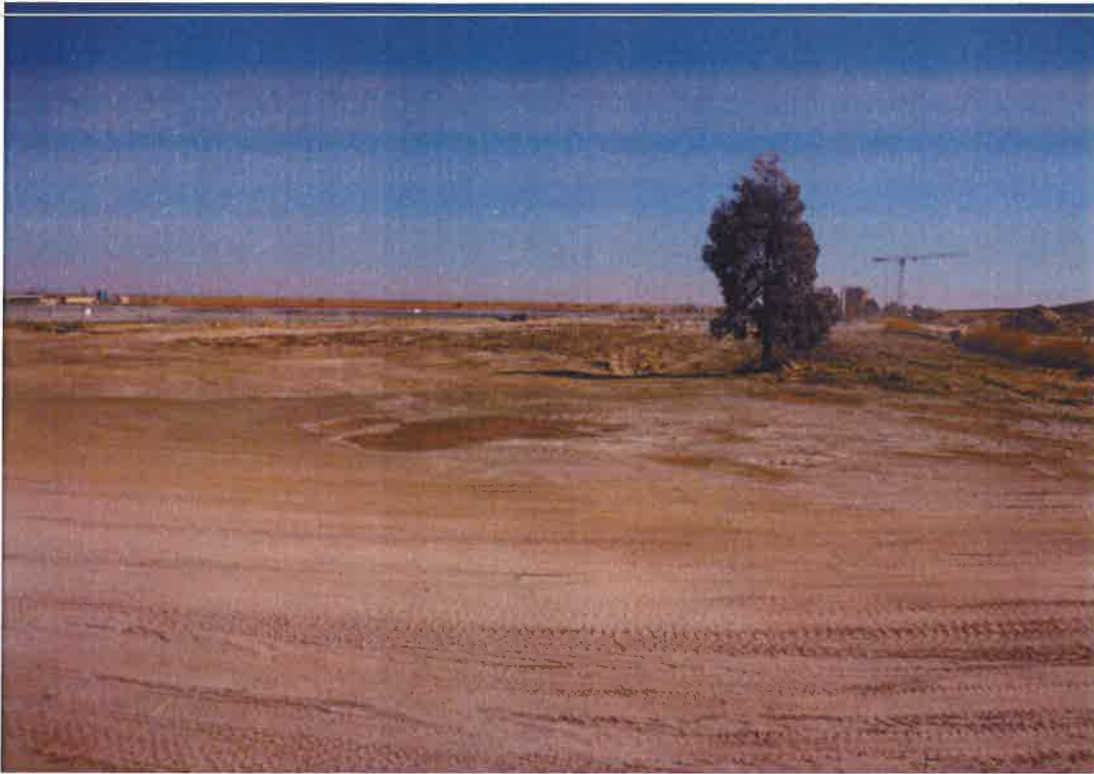
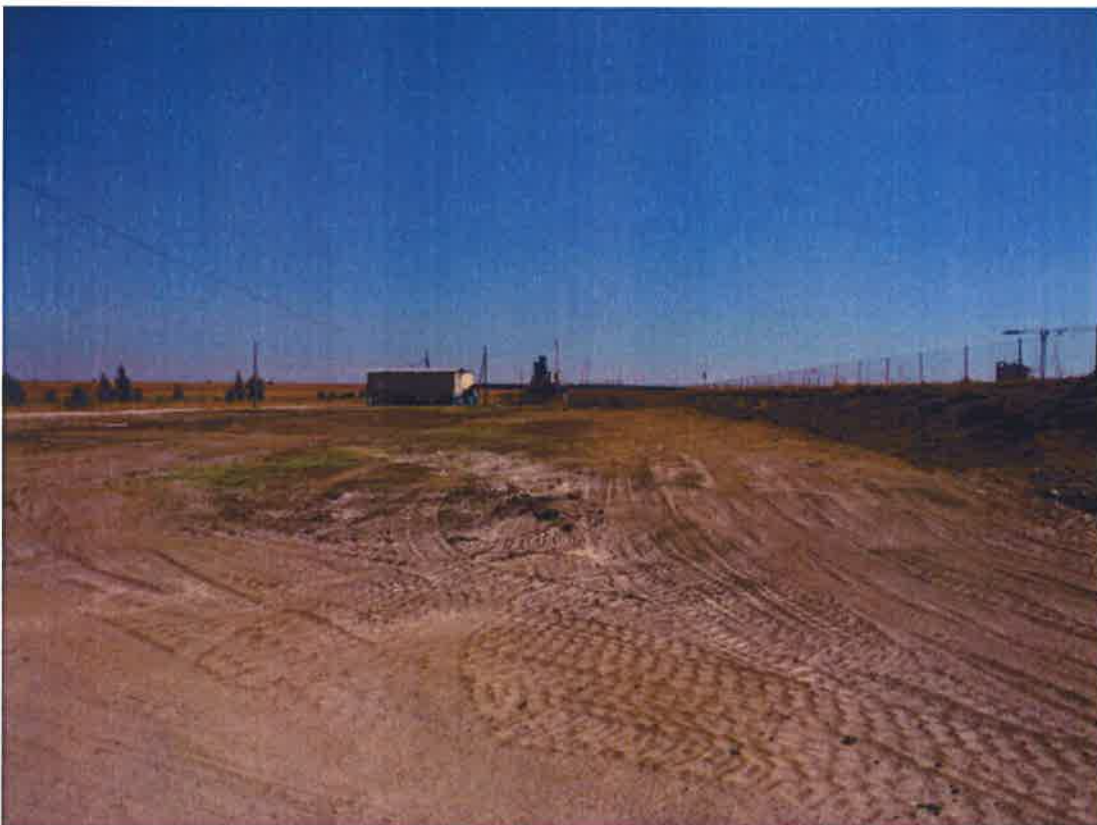
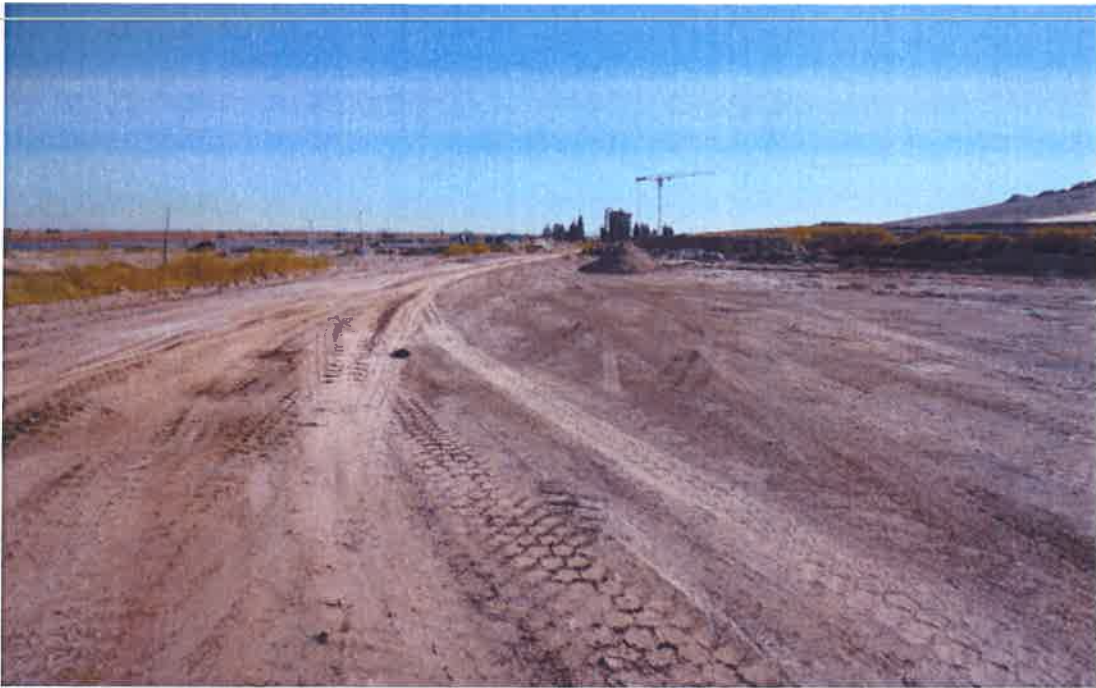
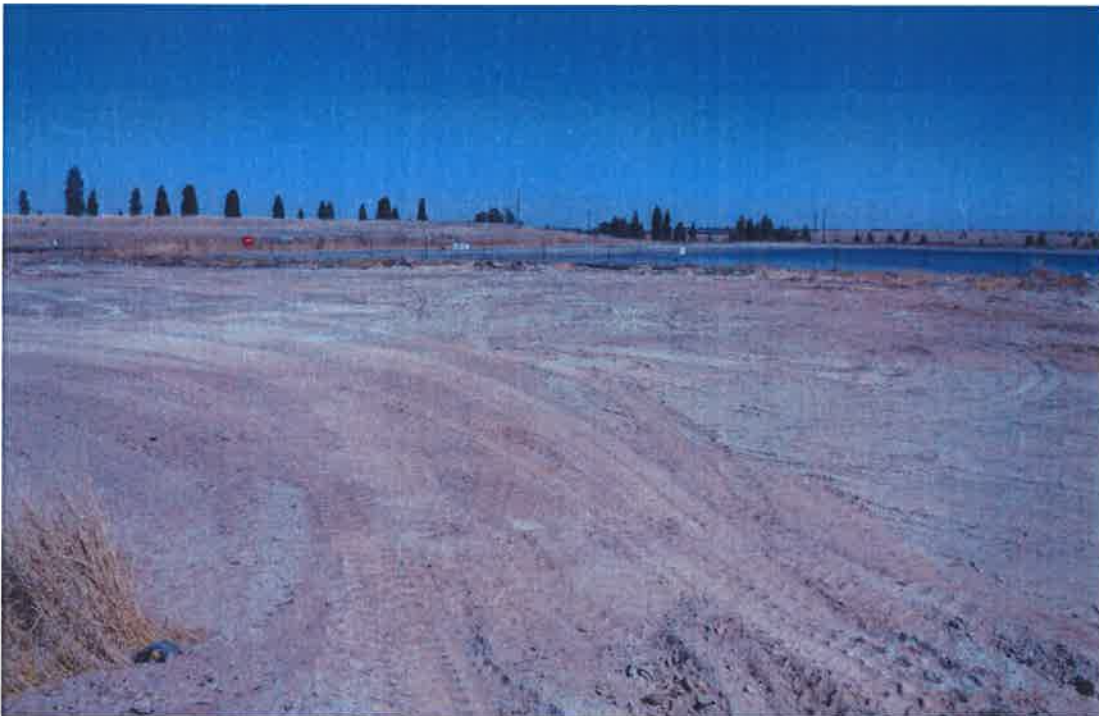
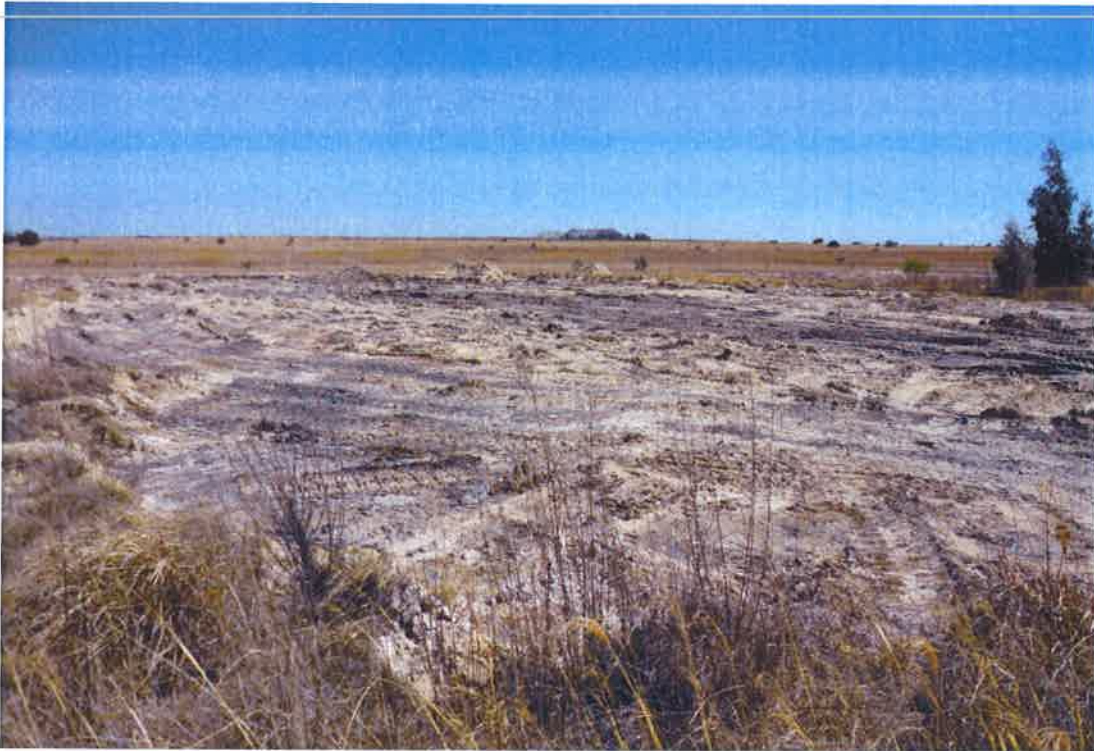
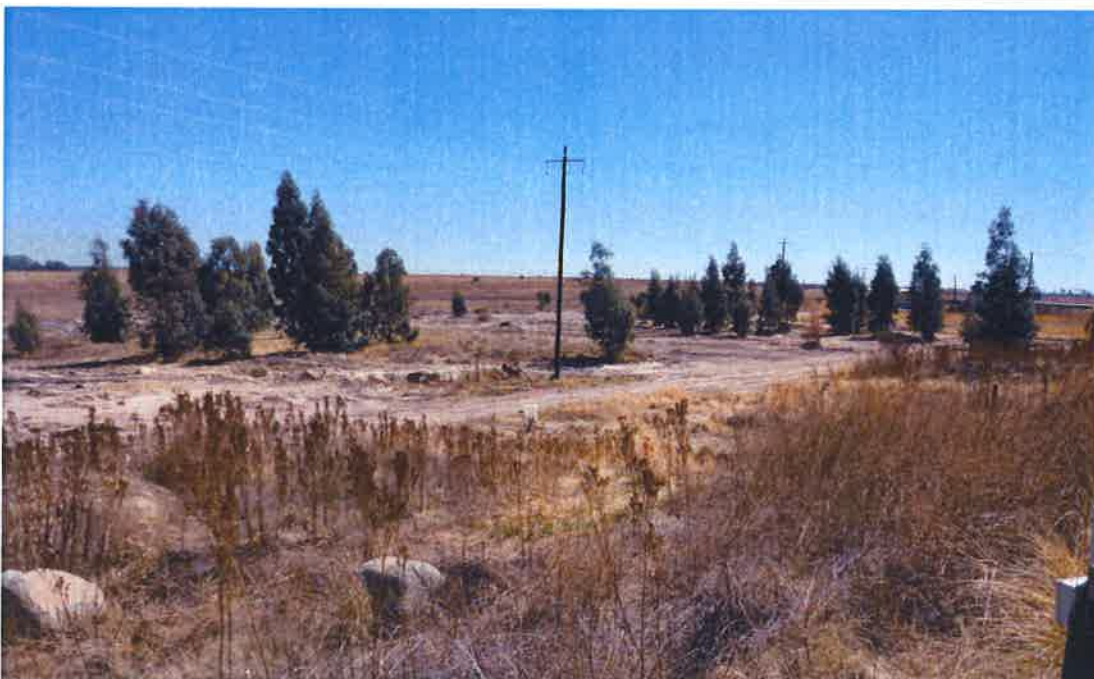
Figure 4: Clean-up in progress around Kareerand TSF (inside containment area)

Figure 5: Cleanup completed around Kareerand TSF (inside containment area) – September 2018

Figure 6: Cleanup completed around Kareerand TSF (inside containment area) - September 2017

Figure 7: Cleanup completed around Kareerand TSF (outside containment area) - March 2018

Figure 8: Cleanup completed around Kareerand TSF (outside containment area) - March 2018

Figure 9: Cleanup completed around Kareerand TSF (outside containment area) - August 2018

Figure 10: Cleanup completed around Kareerand TSF (outside containment area) - August 2018

Figure 11: Cleanup completed around Kareerand TSF (outside containment area) - August 2018

Figure 12: Cleanup completed around Kareerand TSF (outside containment area) - August 2018

- The clean-up of residue around the offices and workshops (see Figures 4 to 12);
- Construction and maintenance of the toewall on the TSF side slope to contain slurry and storm water (Construction complete & maintenance ongoing) (see Figure 13);

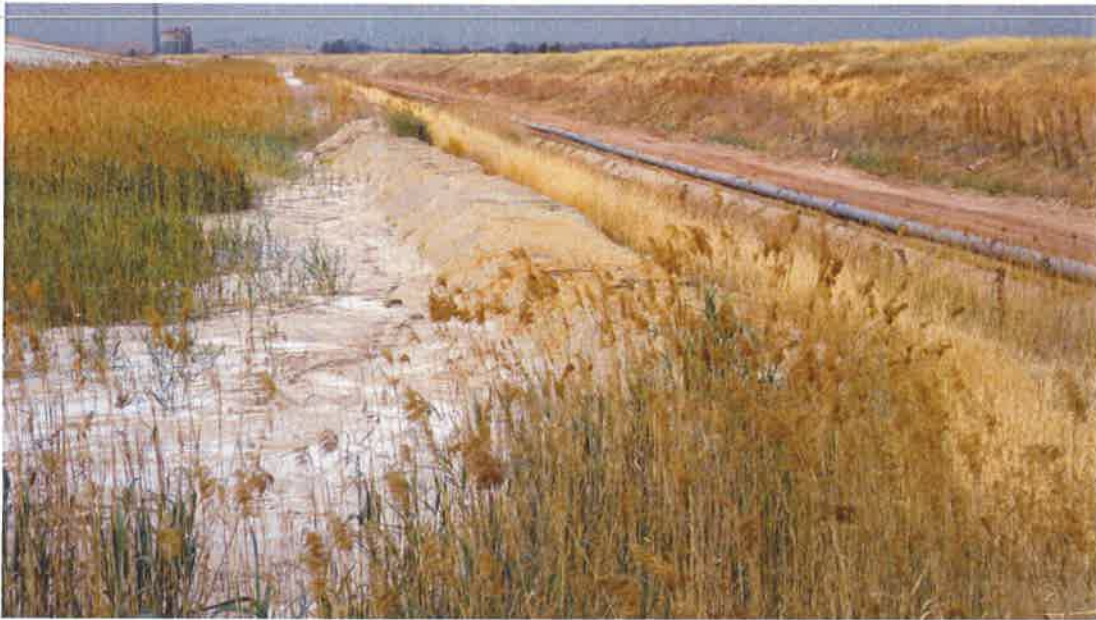
Figure 13: Toewall at bottom TSF sideslopes

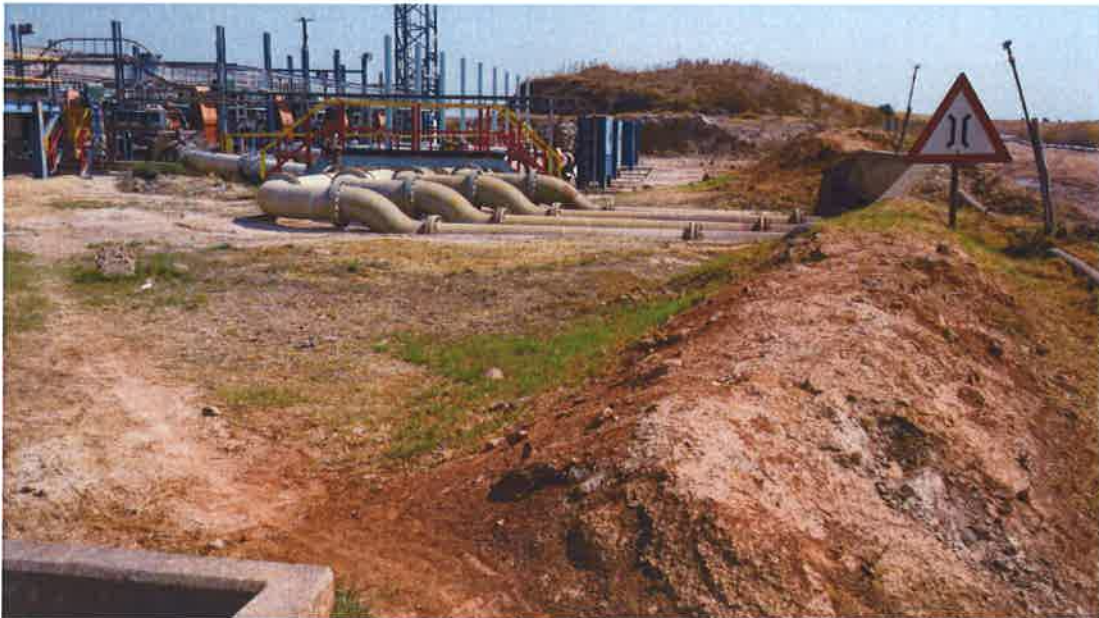
Figure 14: Rolled edge constructed to protect pump station and office

- Construction of a rolled edge at the Kareerand offices and workshops to prevent surface water from flooding the offices and leaving the site, clean / dirty water separation. (see Figure 14);

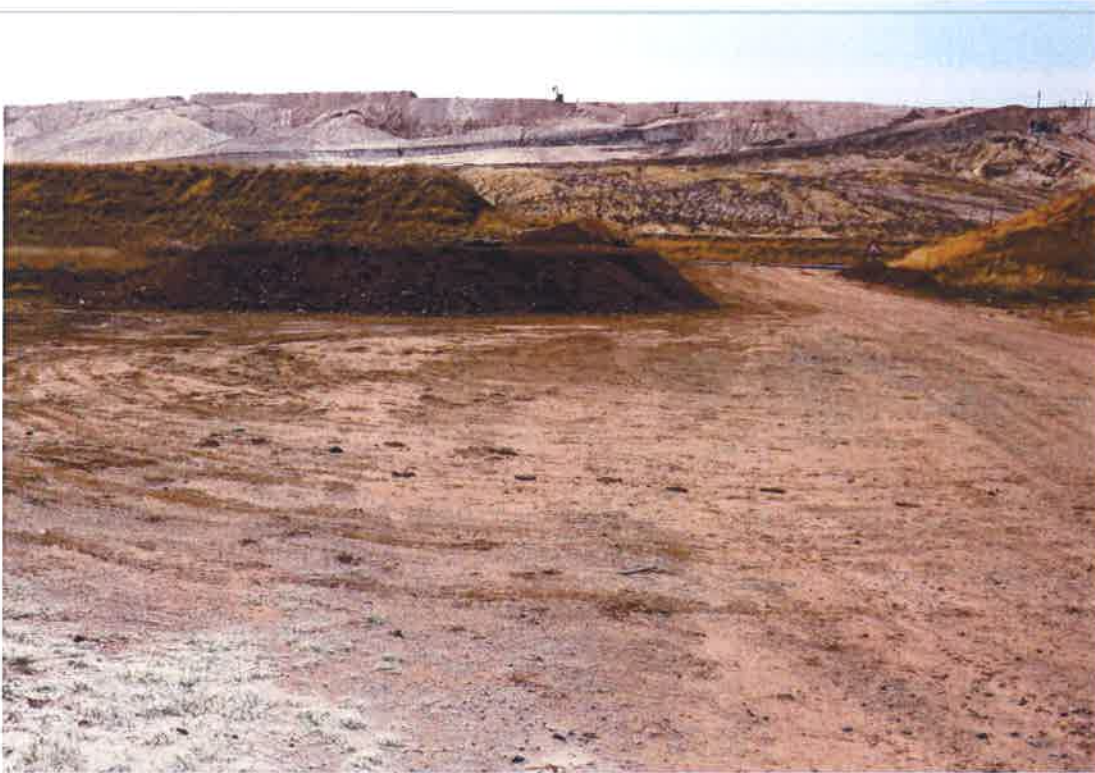
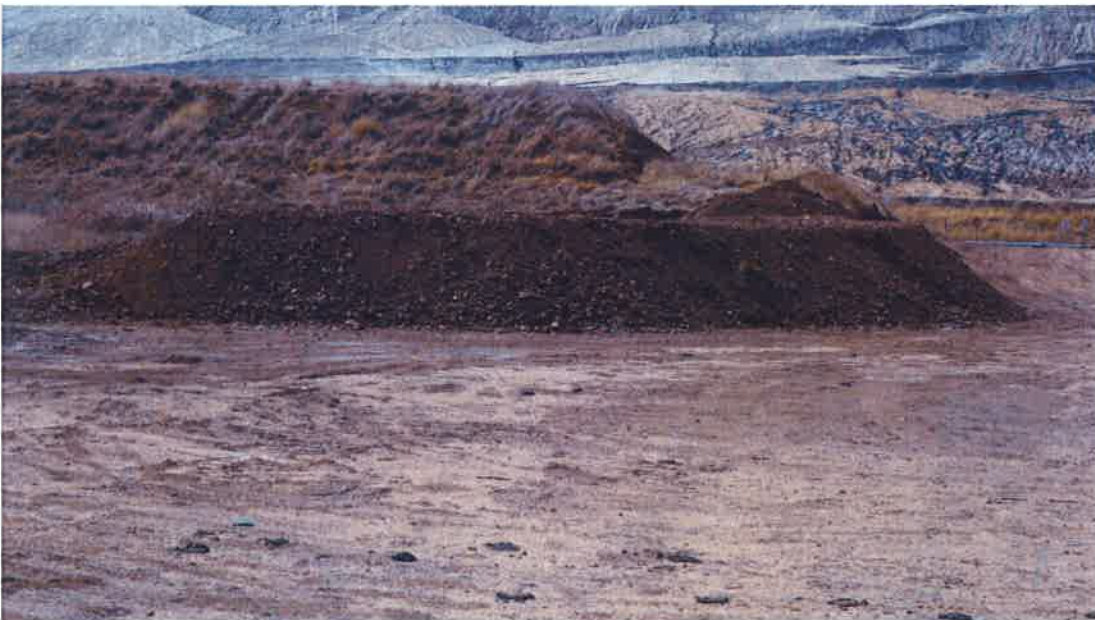
Figure 15: Clean storm water diversion culvert at entrance to Kareerand TSF

Figure 16: Clean storm water diversion culvert at entrance to Kareerand TSF

- Installation of clean storm water diversion culverts at the entrance to Kareerand, to prevent clean water from entering the TSF footprint (see Figures 15 to 16);

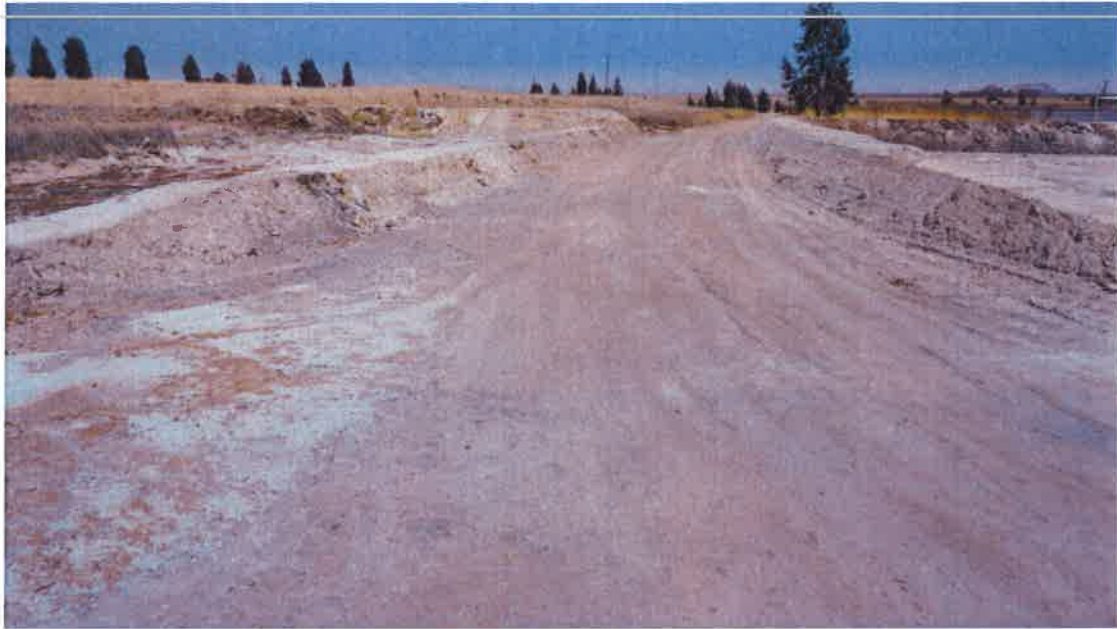
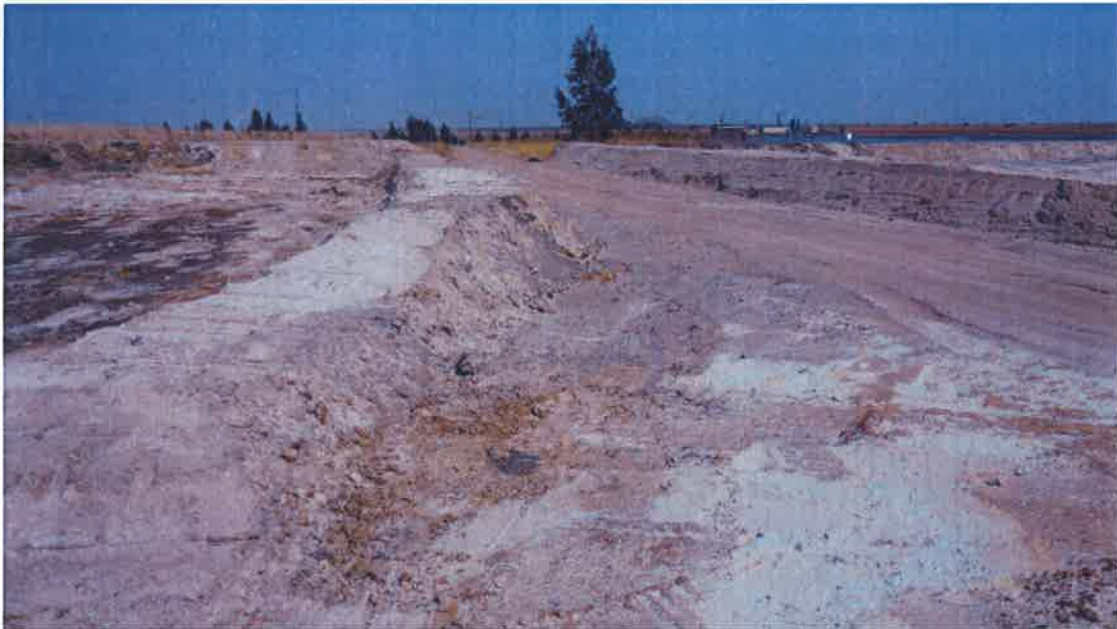
Figure 17: Temporary storm water containment next to return water dams (till East Storm Water Dam constructed)

Figure 18: Temporary storm water containment next to return water dams (till East Storm Water Dam constructed)

- Construction of temporary storm water containment inside Kareerand TSF footprint to attenuate storm water. (see Figures 17 to 18);
- Review current pollution control dam's containment capacity to contain a 1 in 50 year rain storm event;
