MEMORANDUM

To: Adriaan Rossouw, Mpho Mathelele
Cc: Riaz Essack, Thabo Mokgalanyane, Russel Aschmann
From: Nathaniel Seseletsi
Date: 30 January 2019
Subject: Pier No 23 on Elevated road at ORTIA

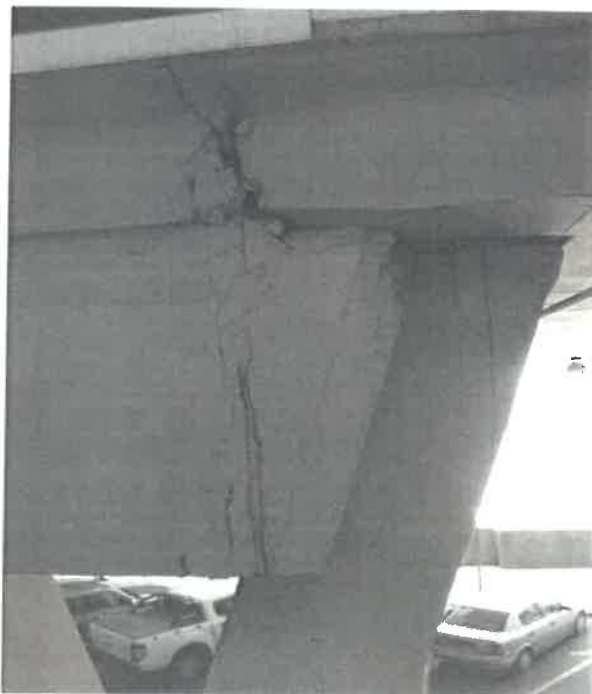
I conducted an inspection on Pier No 23 of the elevated road at ORTIA on 29 January 2019, the inspection was necessitated by a photograph taken by a passenger. The defects on the pier can be generally classified as cracking of the bridge deck and the pier head, Figure 1 below show the nature of the defects on the pier.

Figure 1: Cracking on Pier 23

My findings are that cracks are structural in nature, however they do not affect the structural integrity of the Bridge. The cracks are caused by the Bridge deck bearing directly on to the pier head and the Bridge expansion gap closed by mortar. This defect resulted from bad construction of the Bridge as the Bridge deck was constructed to rest directly on the vulnerable part of the Pier head, this area is vulnerable due to the fact that the concrete at the tip is not reinforced due to cover requirements, furthermore the Bearing Strip seems to be omitted resulting in concrete bearing directly on concrete, Figure 2 below provides an example of how the Bridge should have been constructed

The cracks on pier 23 are structural in nature, however they have little effect on the structural integrity of the bridge. The cracks are aesthetically displeasing and will cause panic to the public should they not be repaired, based on these observations, I hereby recommend that:

- (a) All the loose and spalled concrete and mortar be removed from the Bridge deck and the Pier head
- (b) The bridge ends be neatly finished with mortar (Note: The expansion joint gap should remain open)
- (c) Apply wet to dry epoxy to the exposed surface of the Pier head, then shutter the pier and pour in flowable concrete

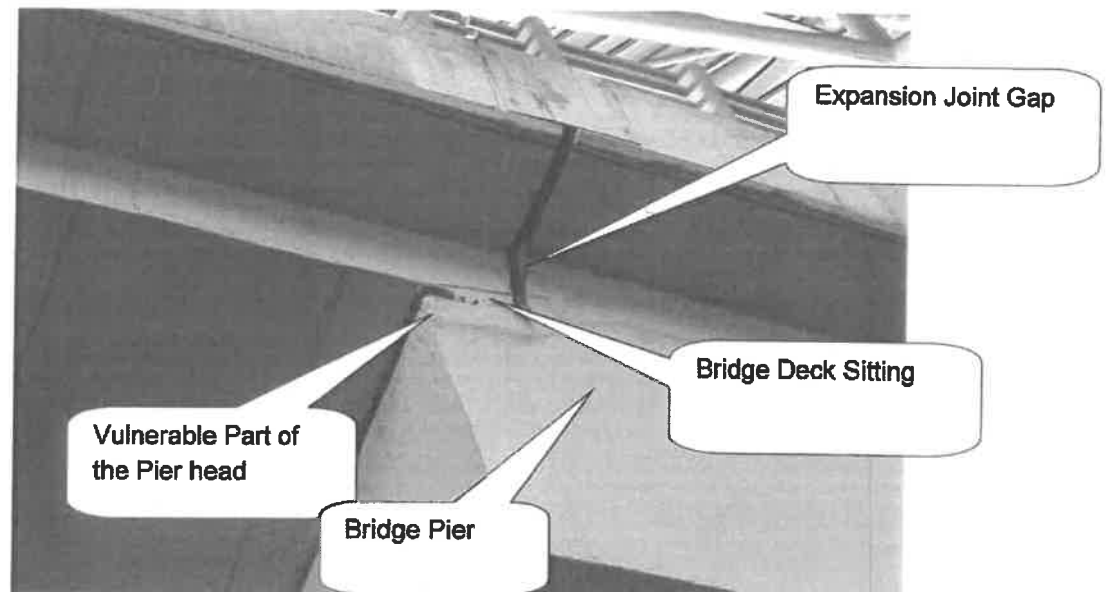
Figure 2: Cracking on Pier 23

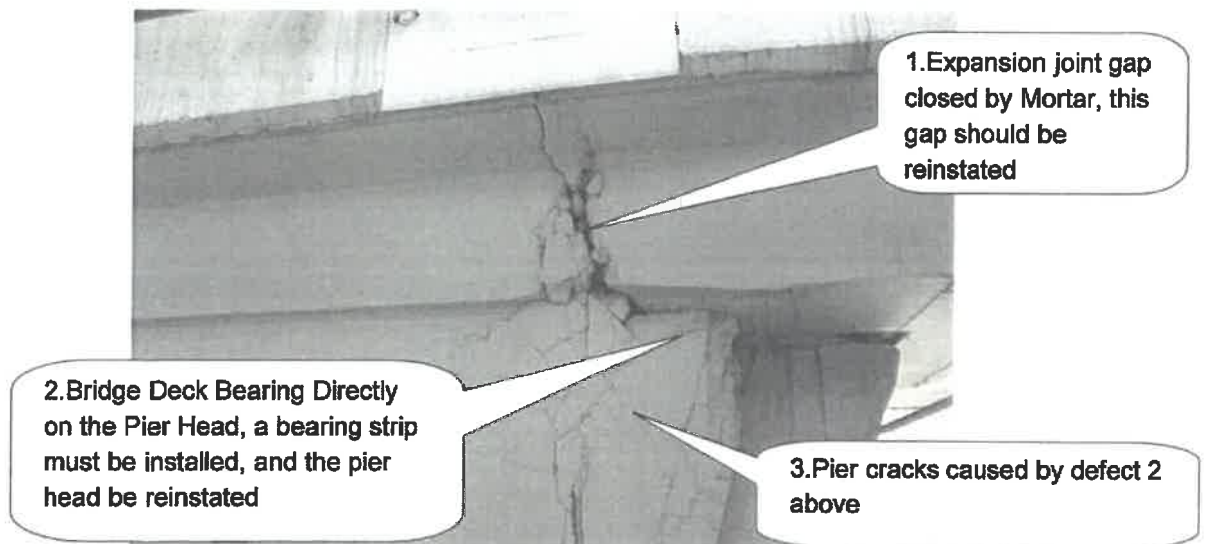
Figure 3 below is a close up on the defects on Pier 23, the expansion joint gap was closed by mortar and it is cracking due to bridge movement, the expansion joint gap needs to be reinstated to allow the bridge to move freely.

Figure 3: Close Up on Pier 23
