**Technical Evaluation Report  
Rectification of 11 houses**

**Municipality** : Ingquza Hill Municipality  
**Town** : Flagstaff  
**Project Name** : Flagstaff 503 Project  
**Project Number** :  
**Number Subsidies** : 503

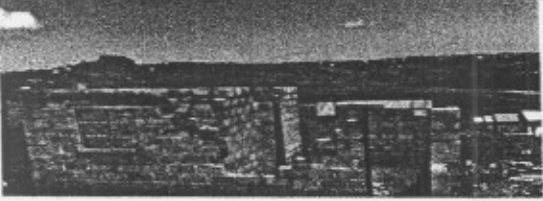
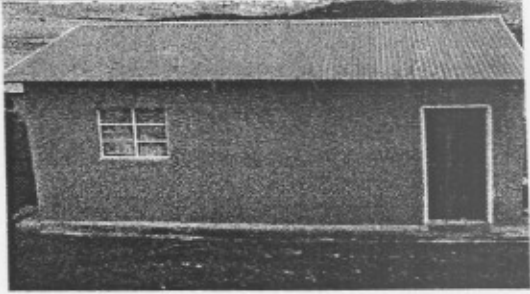
ERF	PHOTO BEFORE	PHOTO AFTER
603

ERF NO	BENEFICIARY	NATURE OF DAMAGE
603	Zoleka Oriana Godo	<ul style="list-style-type: none"> <li>• Roof blown away</li> <li>• Cracked and unstable walls.</li> </ul>
643	Phumelele Swana	<ul style="list-style-type: none"> <li>• Roof blown way</li> </ul>
656	Nokulunga Faith Mdlauzela	<ul style="list-style-type: none"> <li>• Roof blown way</li> </ul>
658	Nozibele Virginia Mvulana	<ul style="list-style-type: none"> <li>• Roof blown way</li> </ul>
716	Nomonde Patience Nombewu	<ul style="list-style-type: none"> <li>• Roof blown way</li> </ul>
735	Zoleka Nomakhwezi Vinywa	<ul style="list-style-type: none"> <li>• Roof blown way</li> </ul>
772	Muriel Nomvuyo Thansi	<ul style="list-style-type: none"> <li>• Roof blown away</li> <li>• Cracked and unstable walls.</li> </ul>
781	Nancy Sizani Ganyile	<ul style="list-style-type: none"> <li>• Roof blown way</li> </ul>
847	Bulelwa Bashe	<ul style="list-style-type: none"> <li>• Roof blown way</li> <li>• Cracked and unstable walls</li> </ul>

Based on the assessment of the damage, the main interventions revolved around stabilizing of the wall structure, replacement of the roof structure and rectifying the obvious discrepancies / shortcomings which compromised the habitability of the houses. Because of unconfirmed ground conditions and poor storm water control, all the eleven houses were provided with a concrete apron and improved storm water drain system. The rain penetration resistance of the walls was improved by plastering and painting of the external walls.

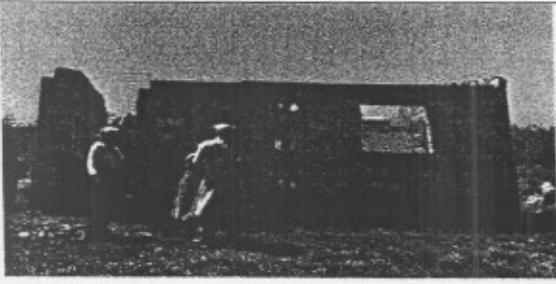
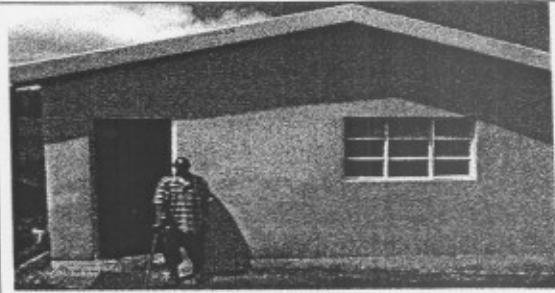
848	Mvikelwa Cwera	<ul style="list-style-type: none"> <li>• Roof blown way</li> <li>• Cracked and unstable walls</li> </ul>
849	Thembesai Pezulu	<ul style="list-style-type: none"> <li>• Roof blown way</li> </ul>
