Medupi Power Station Project Update

Select Committee on Labour and
Public Enterprises

11 September 2013

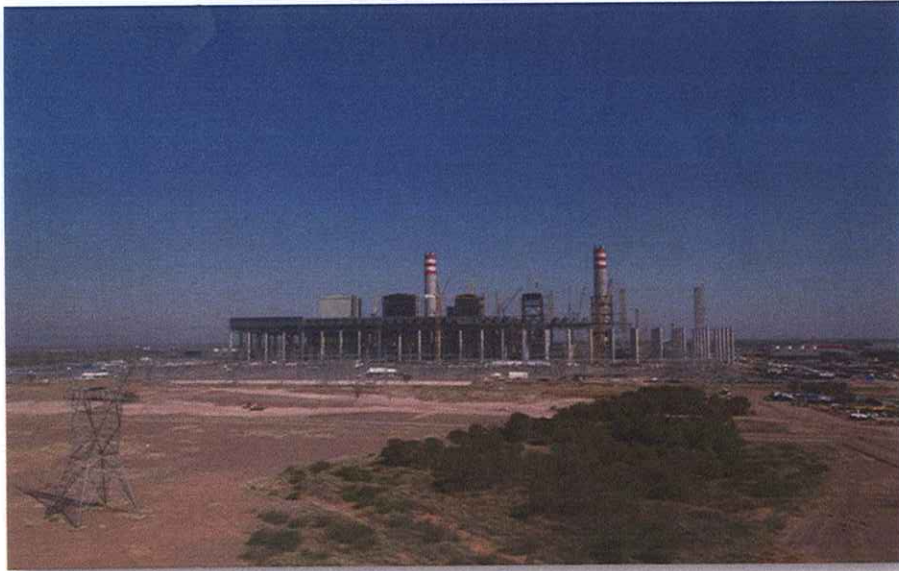
Power Island and high voltage yard

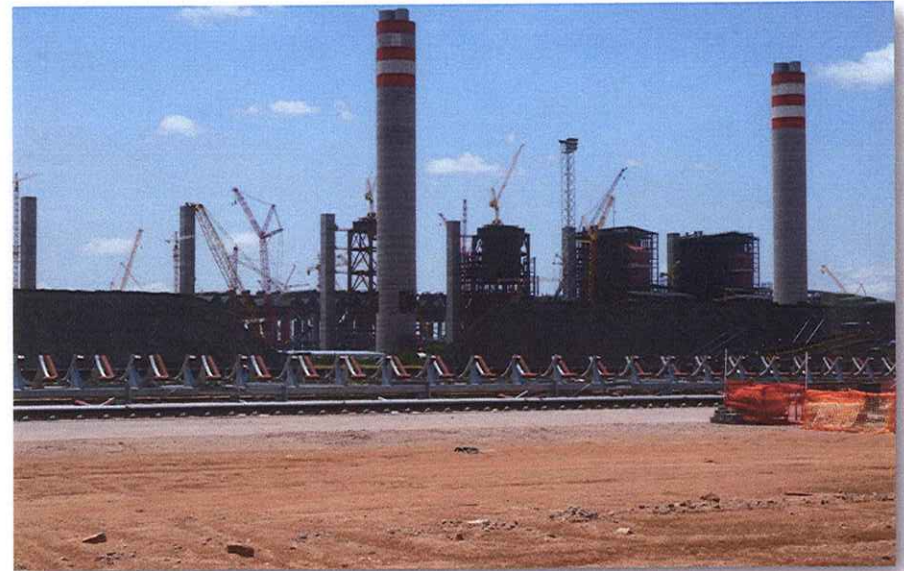
Coal Stockpile, Chimneys & Boiler Structures

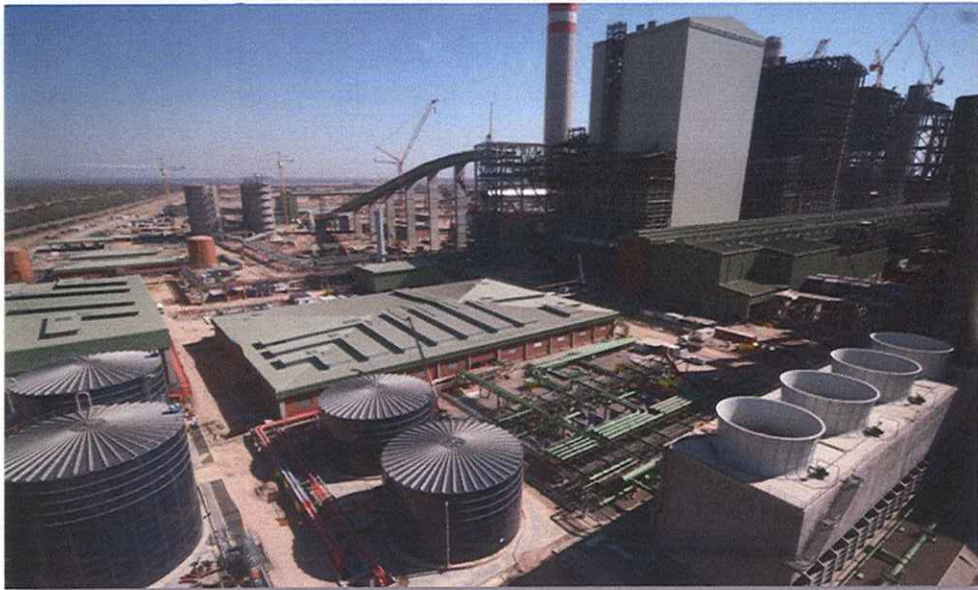
Water Treatment Plant, ACC, Fly Ash Silo's, Unit 6
Boiler House cladding progress

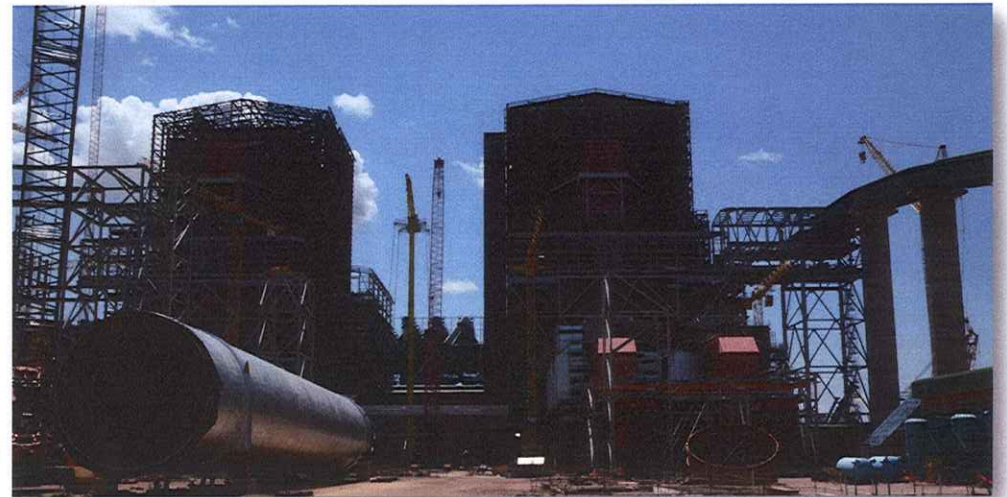
Unit 6 & 5 Boiler Structures

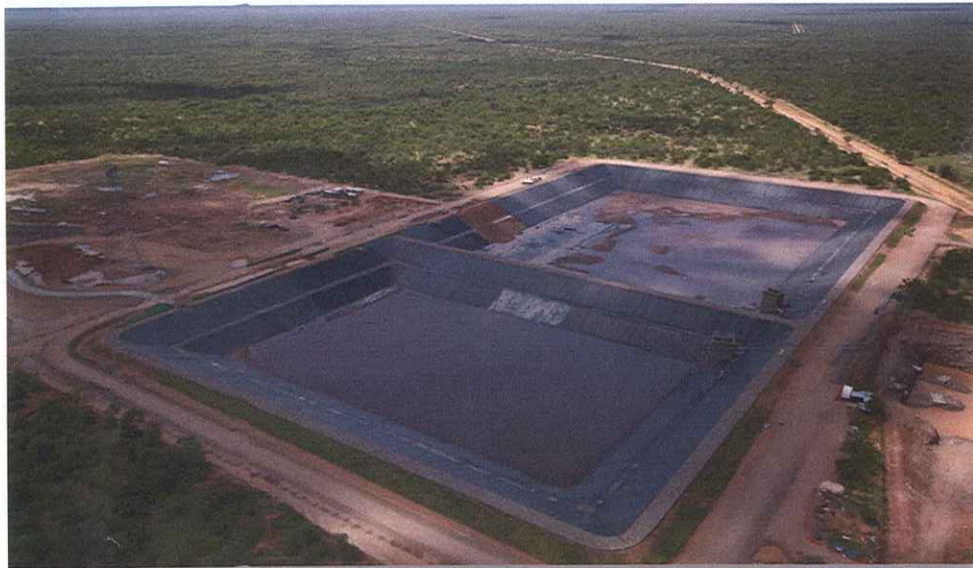
Raw Water Reservoir
