REPORT ON THE JOINT PRELIMINARY INVESTIGATION INTO THE COMPLIANCE PROFILE OF UPL SOUTH AFRICA (PTY) LIMITED and UPDATED RESPONSE TO THE UPL INCIDENT

23 November 2021

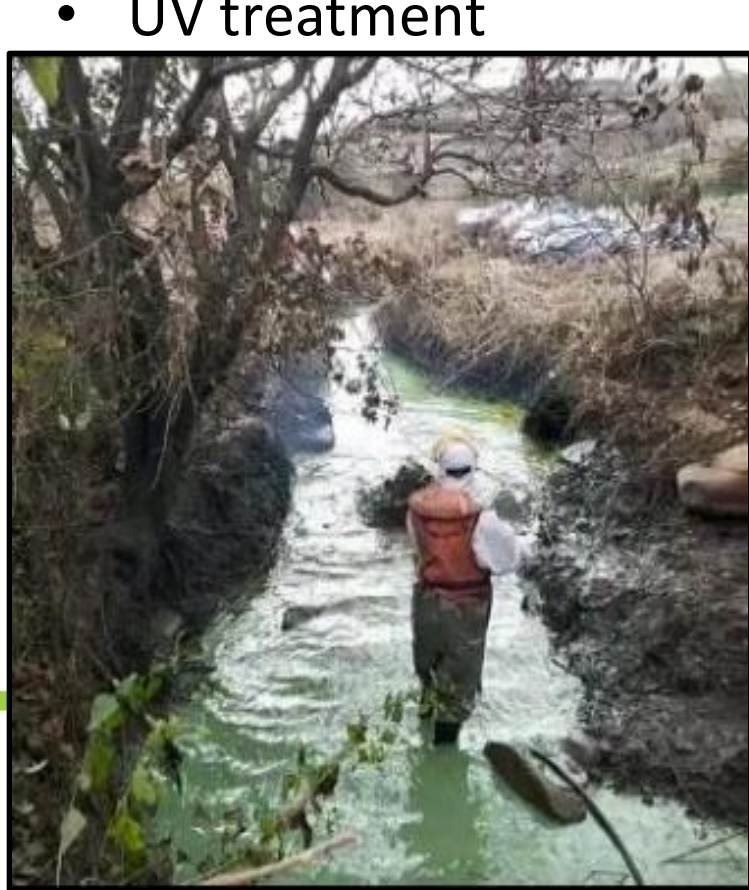
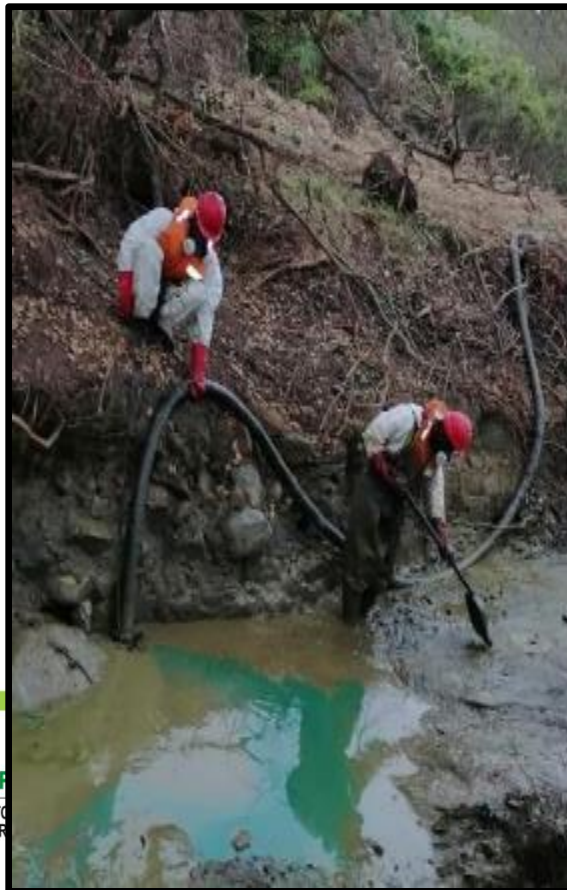
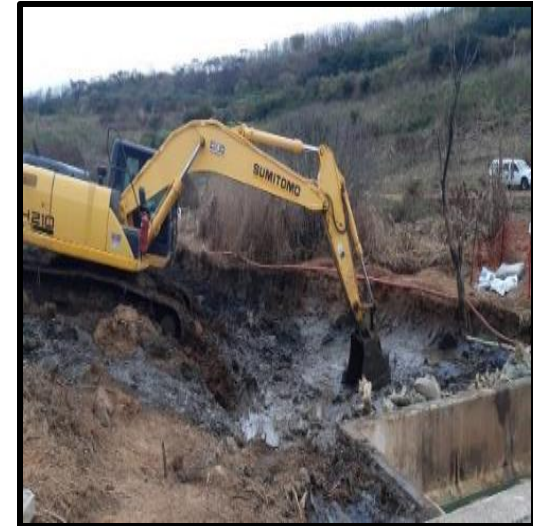
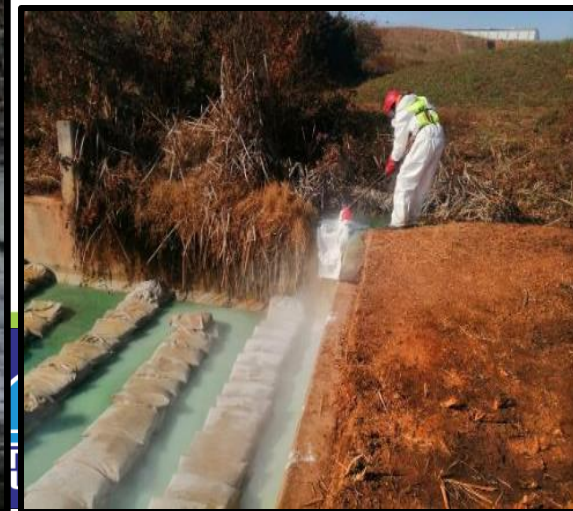
- Pollution Control Dam constructed at the lower end of the UPL site
- Waste removed from the environment:
 - Below the UPL Platform (PCD, tributary to bottom wetland):
 - **Solids: 13,039,384kg (~13 000 tonnes)**
 - Liquids: 23,544,500lt (23.5 Million Litres of liquid)
 - **Dead Fish: 3755kg**
 - Waste disposed from UPL Platform area:
 - Solids: 1 618 990kg (1 618 tonnes)
 - Liquids: 855 380l (0.8 Million Litres)

- Liming
- River cleaning
- Wetland desludging and removal of contaminants
- UV treatment

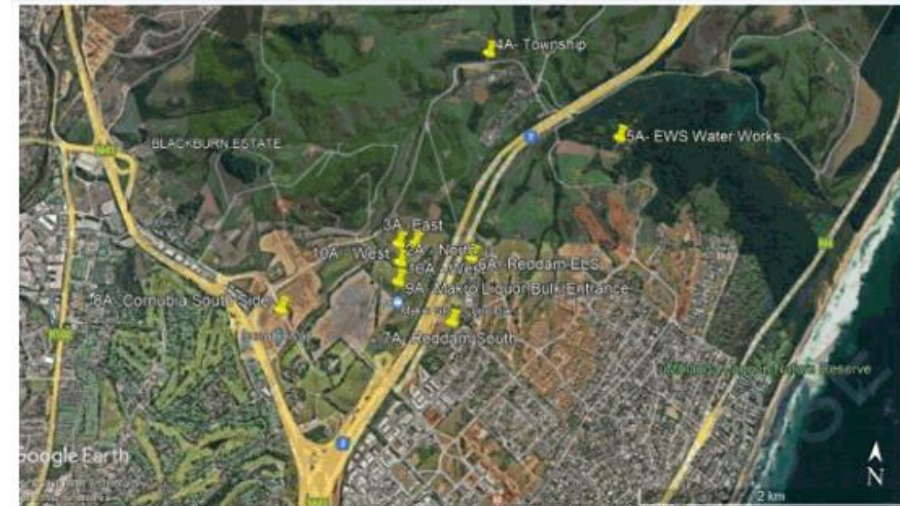
Figure 9: Map depicting Soil sampling location sites

- Apex was appointed to undertake the Human Risk Assessment.
- Identification of susceptible receptors indicated Reddam House School as a potential receptor due to its proximity to UPL.
- Carbendazim was chosen as the indicator pesticide for contamination from fall out/atmospheric deposition.
- Over 26 areas were swabbed and only 2 came back with positive results.
- Carbendazim was detected at the Girls Boarding House tables and Early Learning Stage 4/5 play Storeroom.
- Based on the Minimum Residue Levels (MRLs) and Acute Reference Doses (ARfDs) no significant acute toxicity is anticipated.

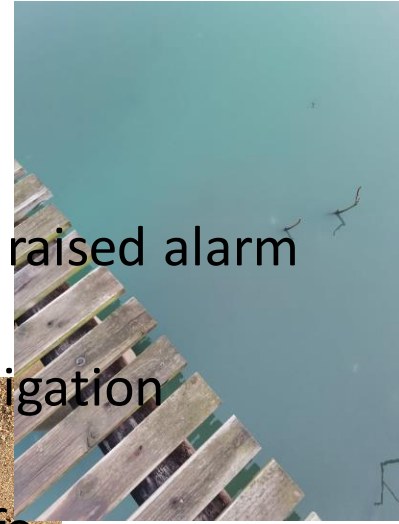
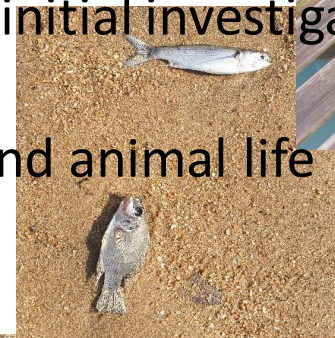
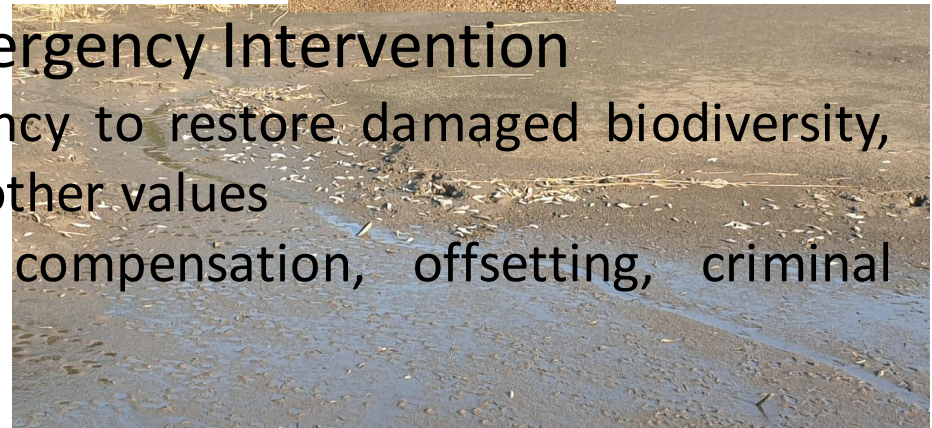
- Post Spill
 - Ezemvelo Rangers discovered the spill (blue water) and raised alarm
 - Massive fish die-off
 - Water body found to be highly toxic during initial investigation
 - 1 species (limited individuals) found alive
 - Chemicals compounds toxic to both plant and animal life
 - Functioning of estuary and NR collapsed
 - Extent of contamination to be determined
- Key Considerations – Post Emergency Intervention
 - Remedial actions post emergency to restore damaged biodiversity, uMhlanga Nature Reserve and other values
 - Restorative justice including compensation, offsetting, criminal liability, etc.
 - Cost recovery

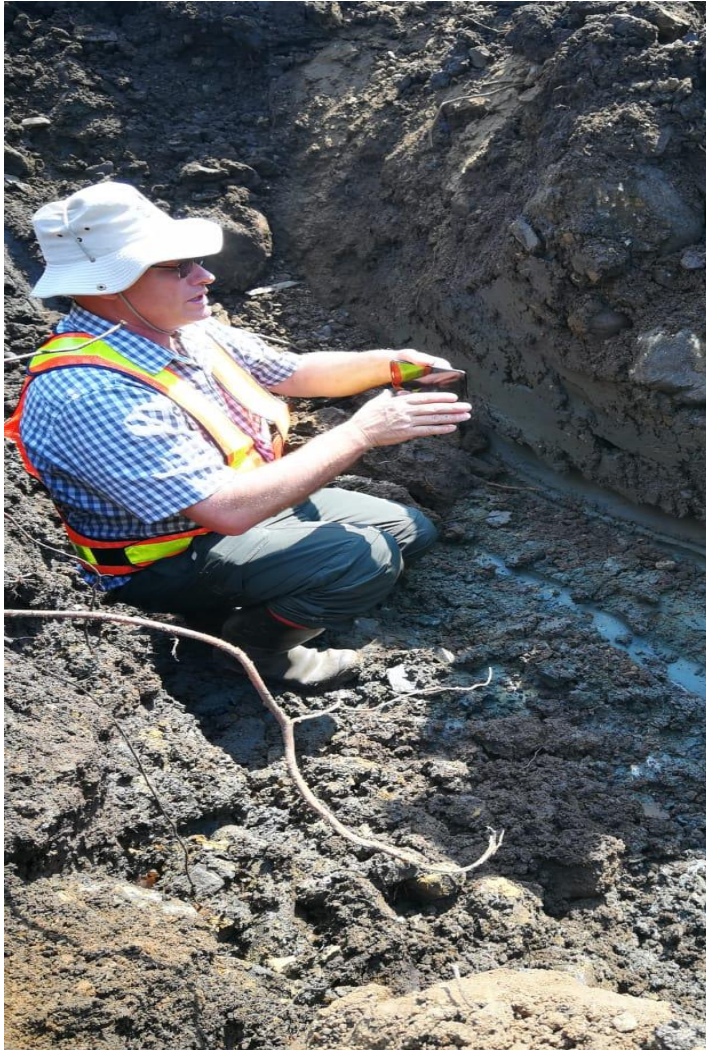
lateral migration of contamination

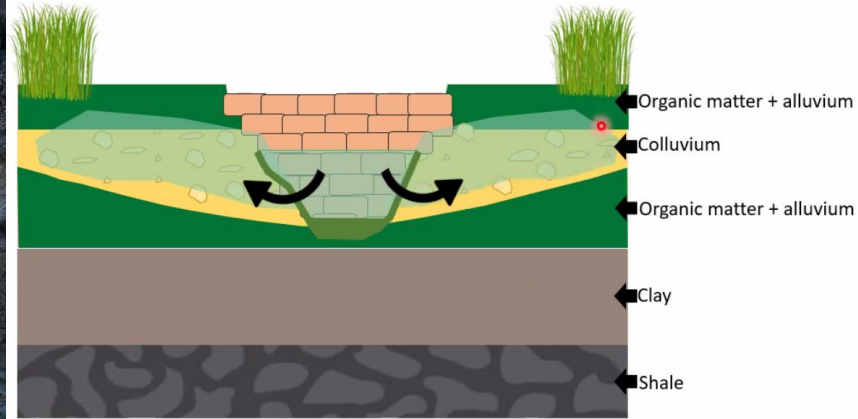
Excavation of channel
