NON-COMPLIANCE FOR CRADOCK WASTE WATER TREATMENT WORK

**SITE VISIT
(Cradock WWTW)
Chris Hani DM**

FILE NO: 16/2/7/Q300/D1

DATE: 16TH SEPTEMBER 2014

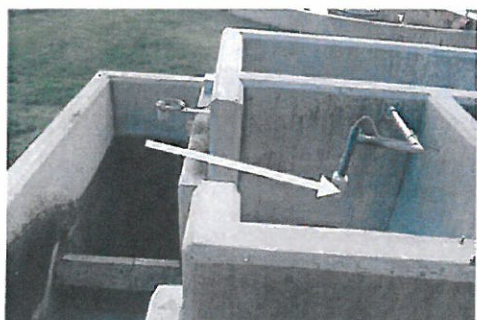
Fig1: (meter sensors inflow)

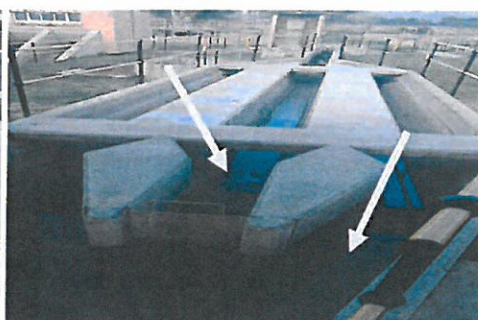
- ✓ The grit channel was not well maintained, too much was observed (*Superintendent mentioned that because there's no inflow they were going to clean and remove the grit*)

Fig2: Grit channel not cleaned

- It is recommended that the maintenance of other aerators be fast tracked so that the plant can be fully functional properly
- It is recommended that the grass growing inside the aerator tank be removed because it affects the effectiveness of the aerators.
- The grit channel must be cleaned regularly
- The ponds must be well maintained, sludge must be removed.

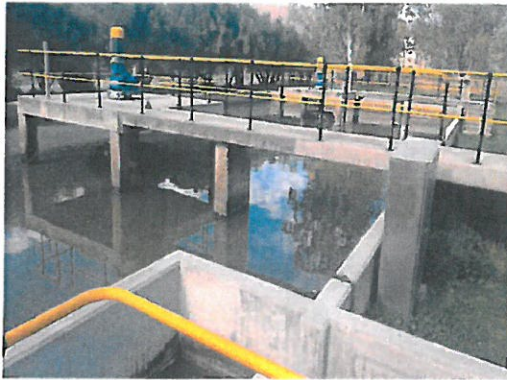
Fig3: Aerators functional

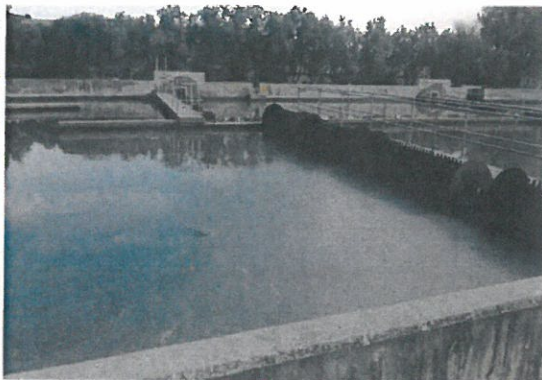
- ✓ There are only 2 aerators working at the plant and the rest need maintenance (in total there are 8 aerators available).
- ✓ In one of the aerator chamber grass has grown and this is affecting the overall process of aeration.

Fig4: Aerator not functional

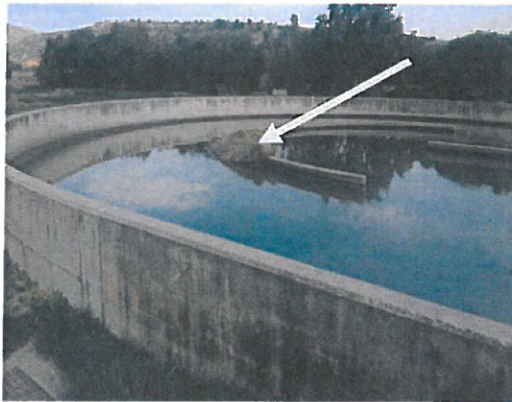
Fig5: Grass growing (Aerator tank)

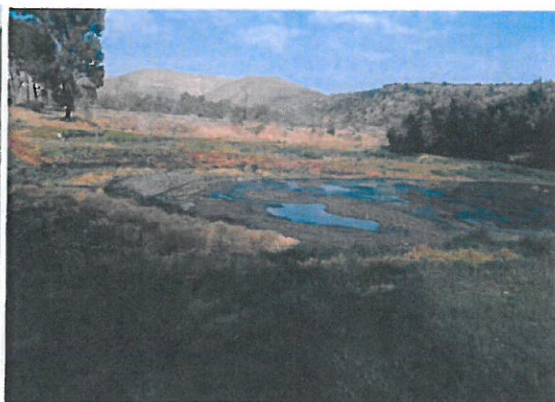
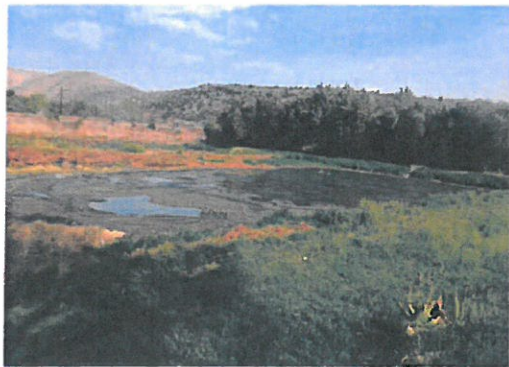
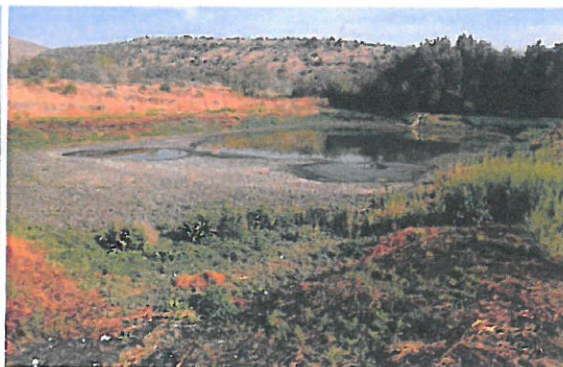
- ✓ There are two ponds that are used to return effluent to the inflow. These ponds have too much sludge and need to be desludged. They are in poor state and not maintained properly.

Fig6: Sludged pond

Fig7: Sludged pond

Fig8: Sludged pond

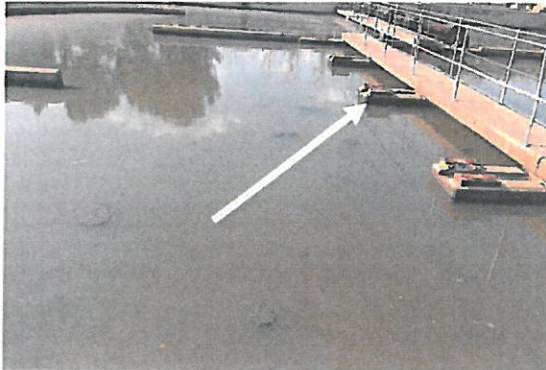
Fig9: Aerator removed

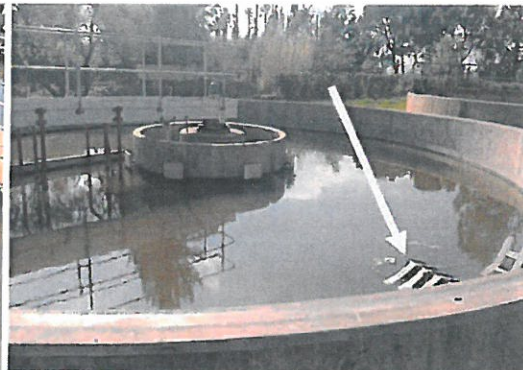
- ✓ All the settling tanks are working well; the tanks will have to be cleaned regularly.
- ✓ The chlorination is gas and is working properly, but at the time of visit there was no electricity.

Fig10: Settling tank (material floating)
