ENGINEERING SERVICES CHIEF DIRECTORATE

PROJECT DETAILS	
CLIENT DEPARTMENT	South African National Defence Force
PROJECT NUMBER:	N/A
REPORT TITLE	Flood damage investigation into collapsing perimeter boundary wall

REPORT STAGE			
	Investigation Report	Status Quo Report	Preliminary Design Report
	IR	SQR	PDR
Tick [x]	x

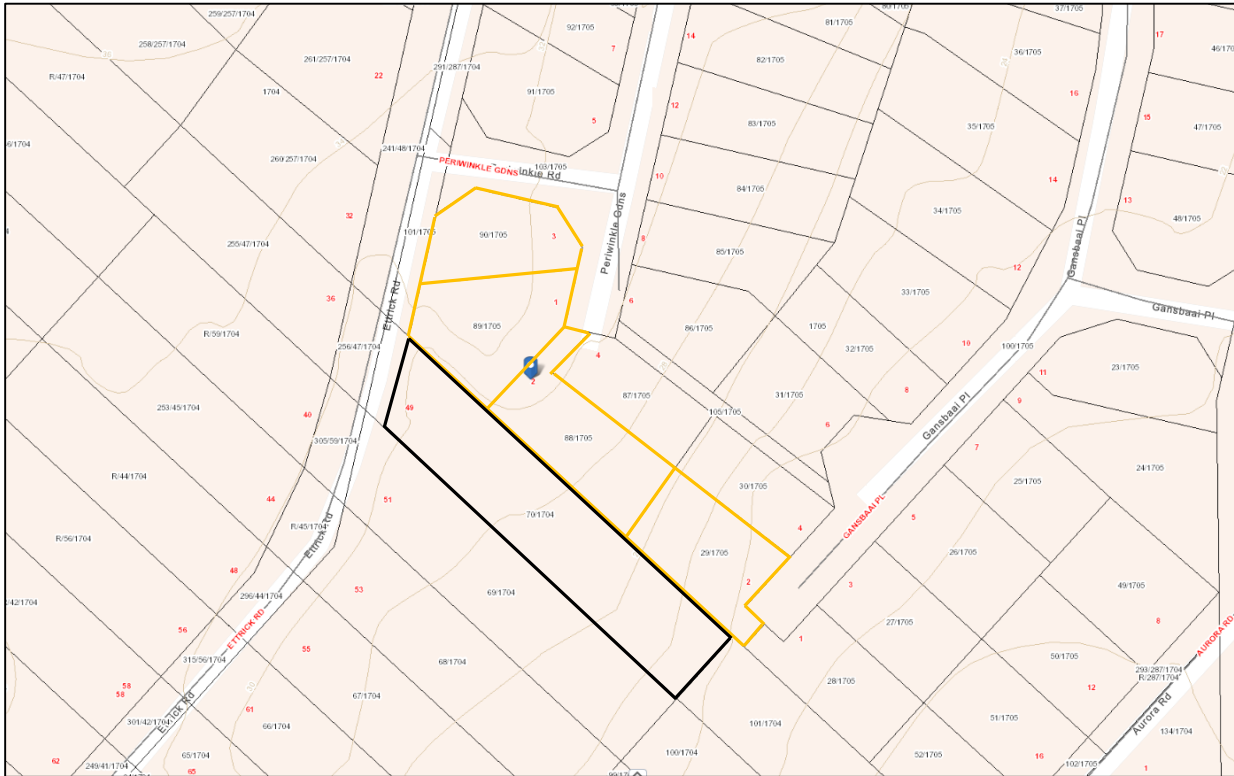
Figure 3-1: GIS illustration of SANDF Erven (orange) against the Affected Civilian Boundary Wall at 49 Ettrick Road (black)

- The precast concrete panel boundary wall belonging to 49 Ettrick Road was constructed in such a way that it served as an unreinforced retaining wall against approximately 300mm of retained soil on the up slope. The wall has no weep holes to allow excess water to escape.
